Re: Paseo Vista Units A1, A2 and A3 plus reverses

PASEO VISTA
UNITS A1, A2, A3
1960 and 2290 DUTTON AVENUE
SANTA ROSA, CA

Subject: Final Report
Results of Geotechnical Observations
And Special Inspection & Testing Services
Paseo Vista Townhomes Subdivision: Building 9C, Lot 1-25
492 Palmilla Place
Santa Rosa, California
APN: 043-400-025
Permit No. BLD17-4952

COMPRESSION TEST REPORT

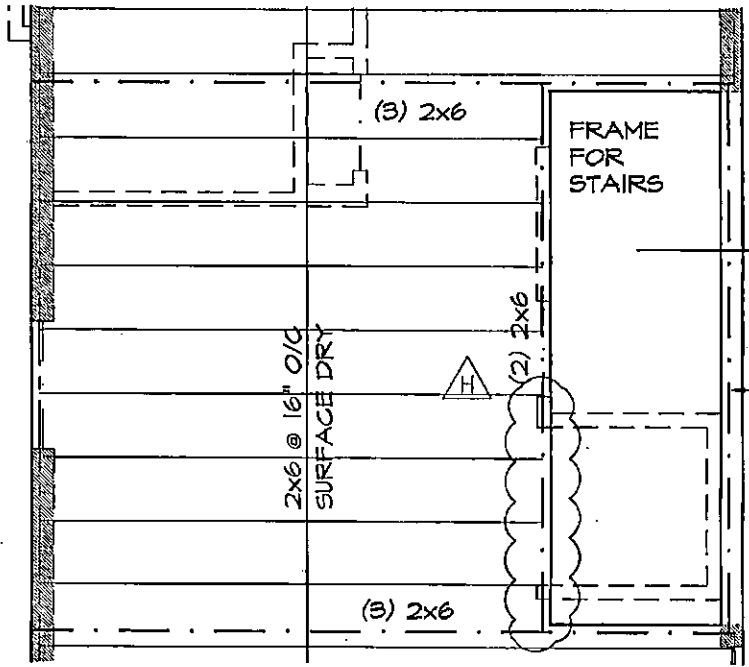
PARTIAL LOWER CORE CEILING FRAMING PLAN

The door/header into the washing machine alcove has been removed and the washing machine has been moved to the garage and the refrigerator has been moved to the alcove. This revision has no structural impact.
