Re: Site & soil evaluations at 11405 Skyline Road in Forestville, CA 95436  
APN: 081-010-008 Permit #: WSR21-0528

## Pre-Perc Field Notes

Re: Results of Soil Texture Analysis  
By Bouyoucos Hydrometry Method

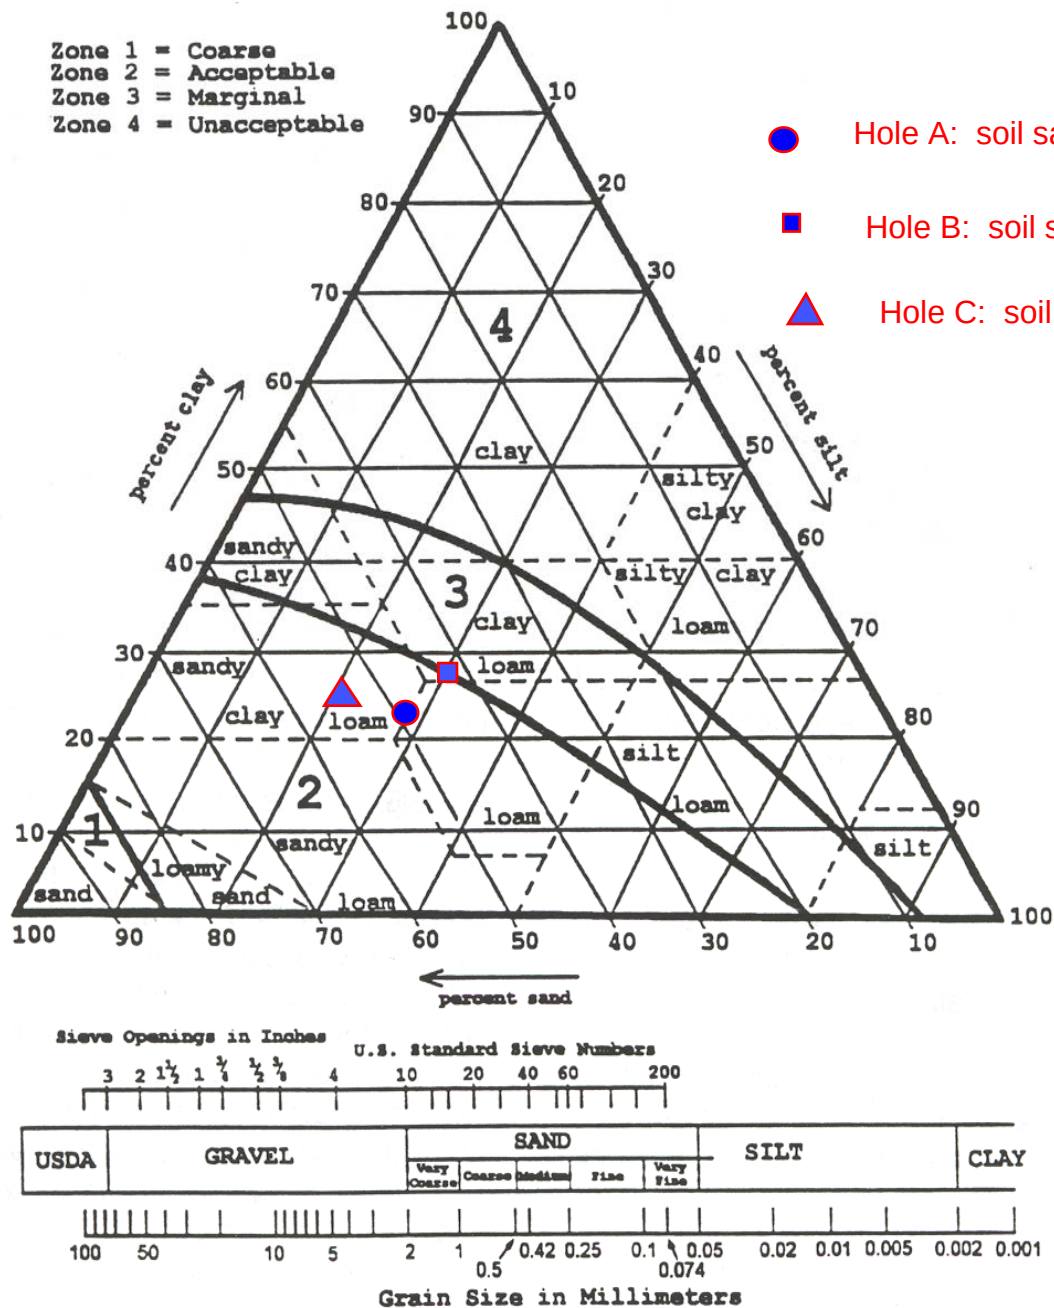
11405 Skyline Road in  
Forestville

● Hole A: soil sample 40-55"

■ Hole B: soil sample 20-35"

▲ Hole C: soil sample 20-45"

Hi Ben. The pre-perc soil lab test shows one of the soil samples to be within the curve line between zone 2 and zone 3 in the soil triangle texture chart. How do we interpret this? Zone 2 (no percolation test ) or zone 3 (need percolation test)? Specifically soil sample in soil profile hole B from 20-35" depth.
