The following application has been filed with the Sonoma County Permit and Resource Management Department.

| <b>File Number:</b> | <b>CPH26-0009</b> |
| <b>Site Address:</b> | <b>435 McChristian Ave., Bodega Bay</b> |

**Project Description: Coastal Permit with Hearing to expand the original 930 sq. ft. house to a 1,752 sq. ft. primary residence with a new 144 sq. ft. shed and 36 sq. ft. carport on a 1.0-acre parcel. The proposed building height will remain unchanged and additional massing is minimal. The carport will match the house design and be located within the existing parking area.**

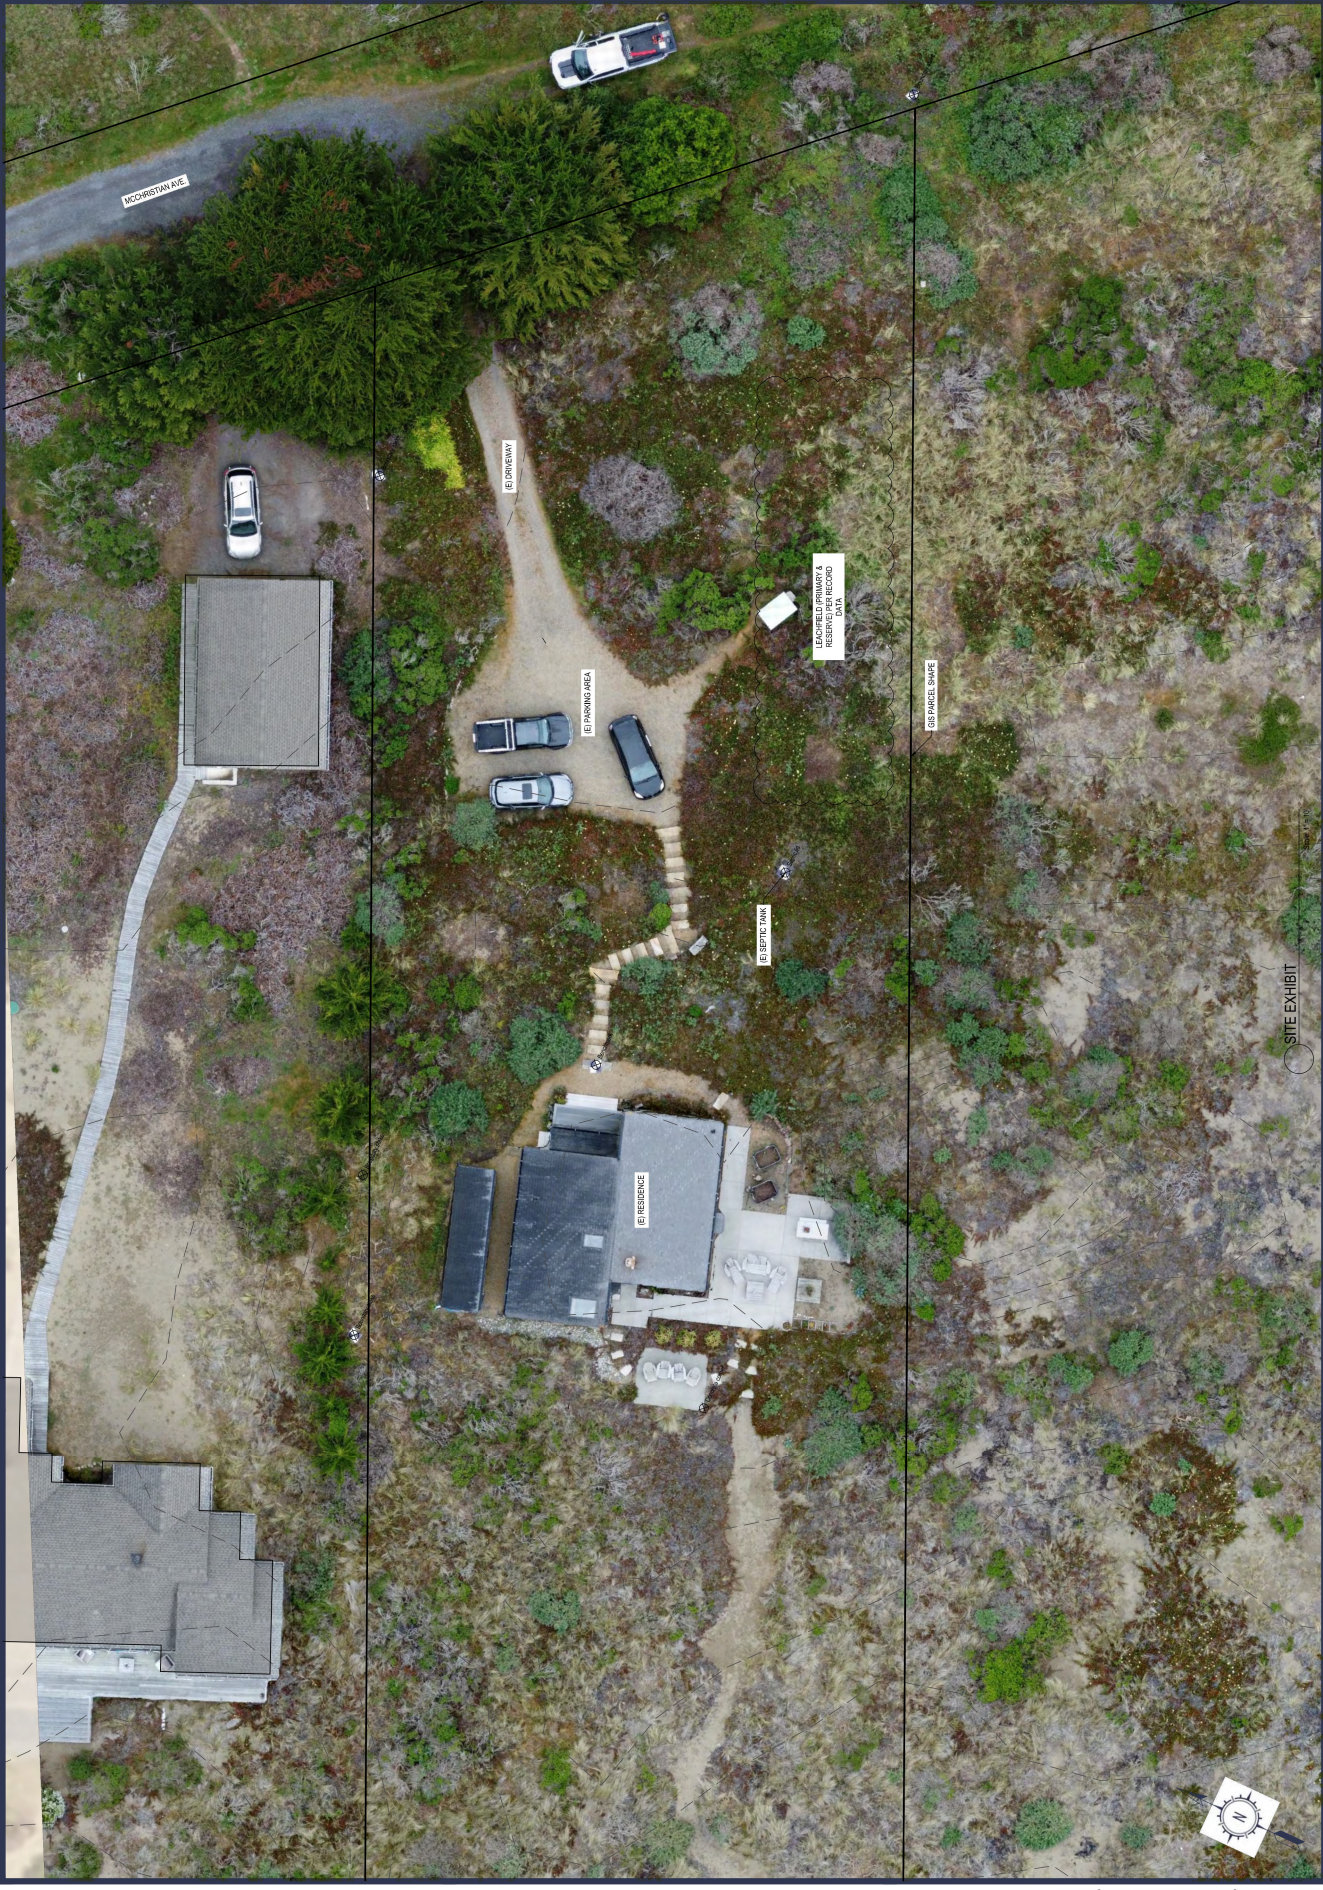
A0.11

Site Plan -  
Existing

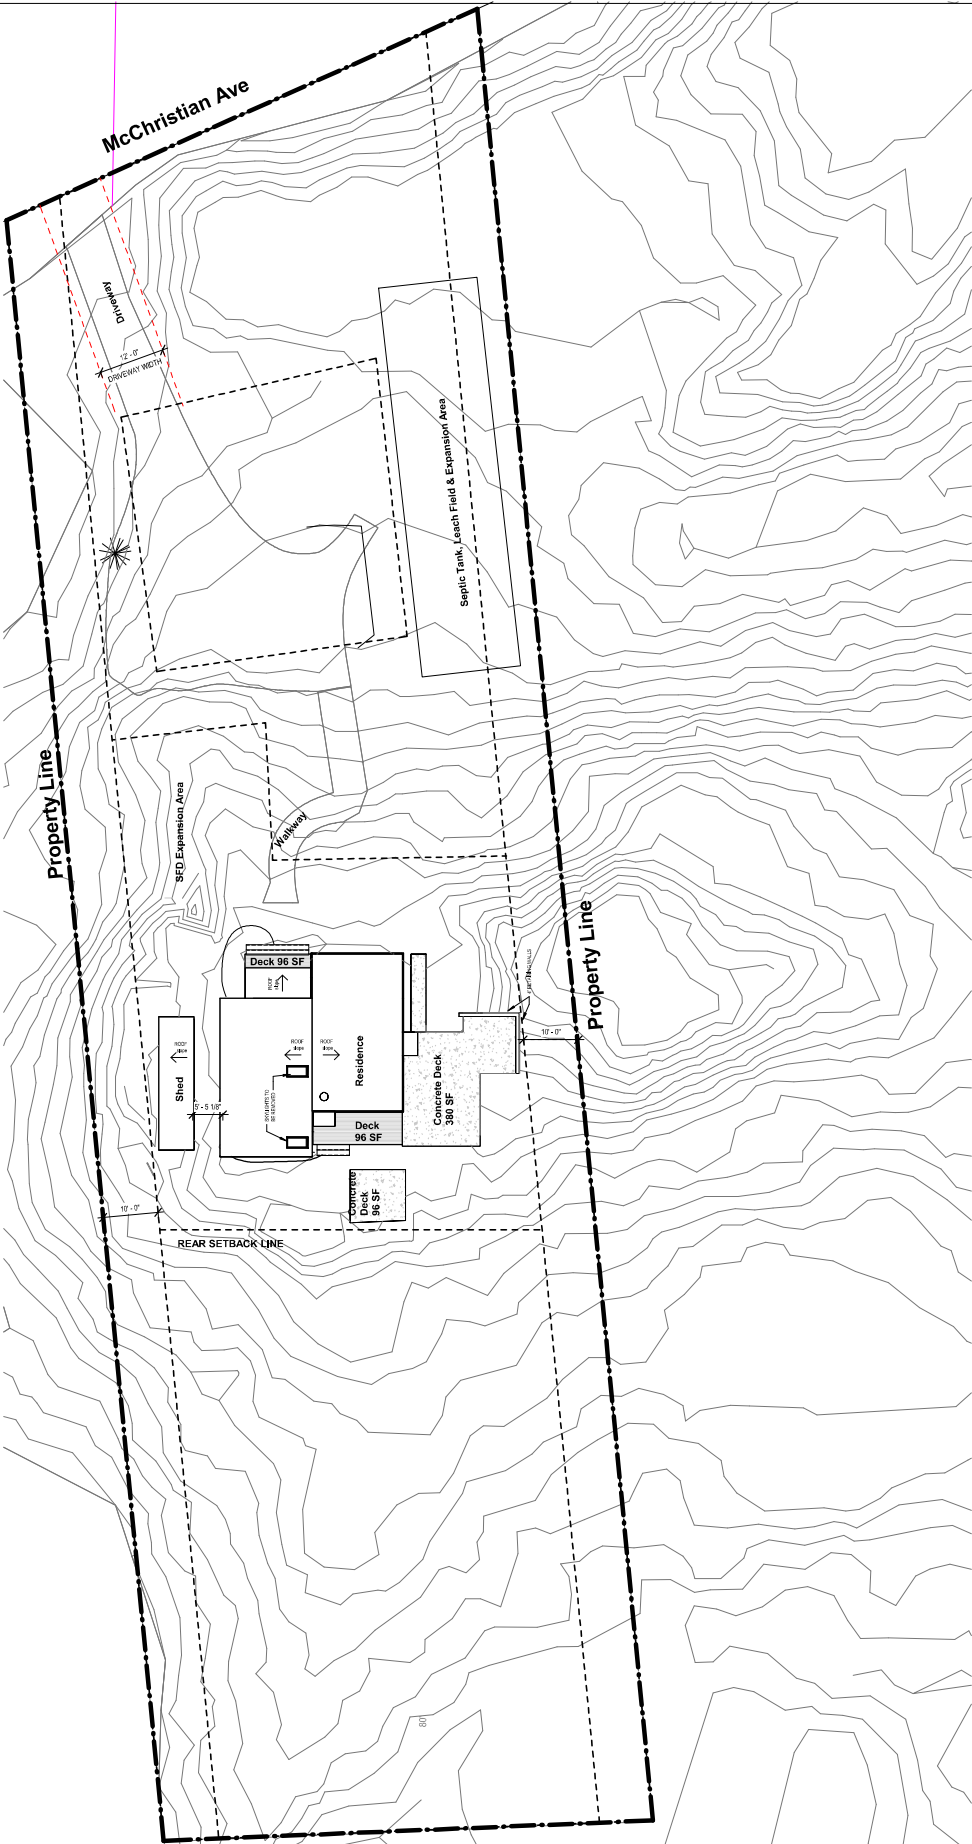
A1.00

### Site Plan - Proposed

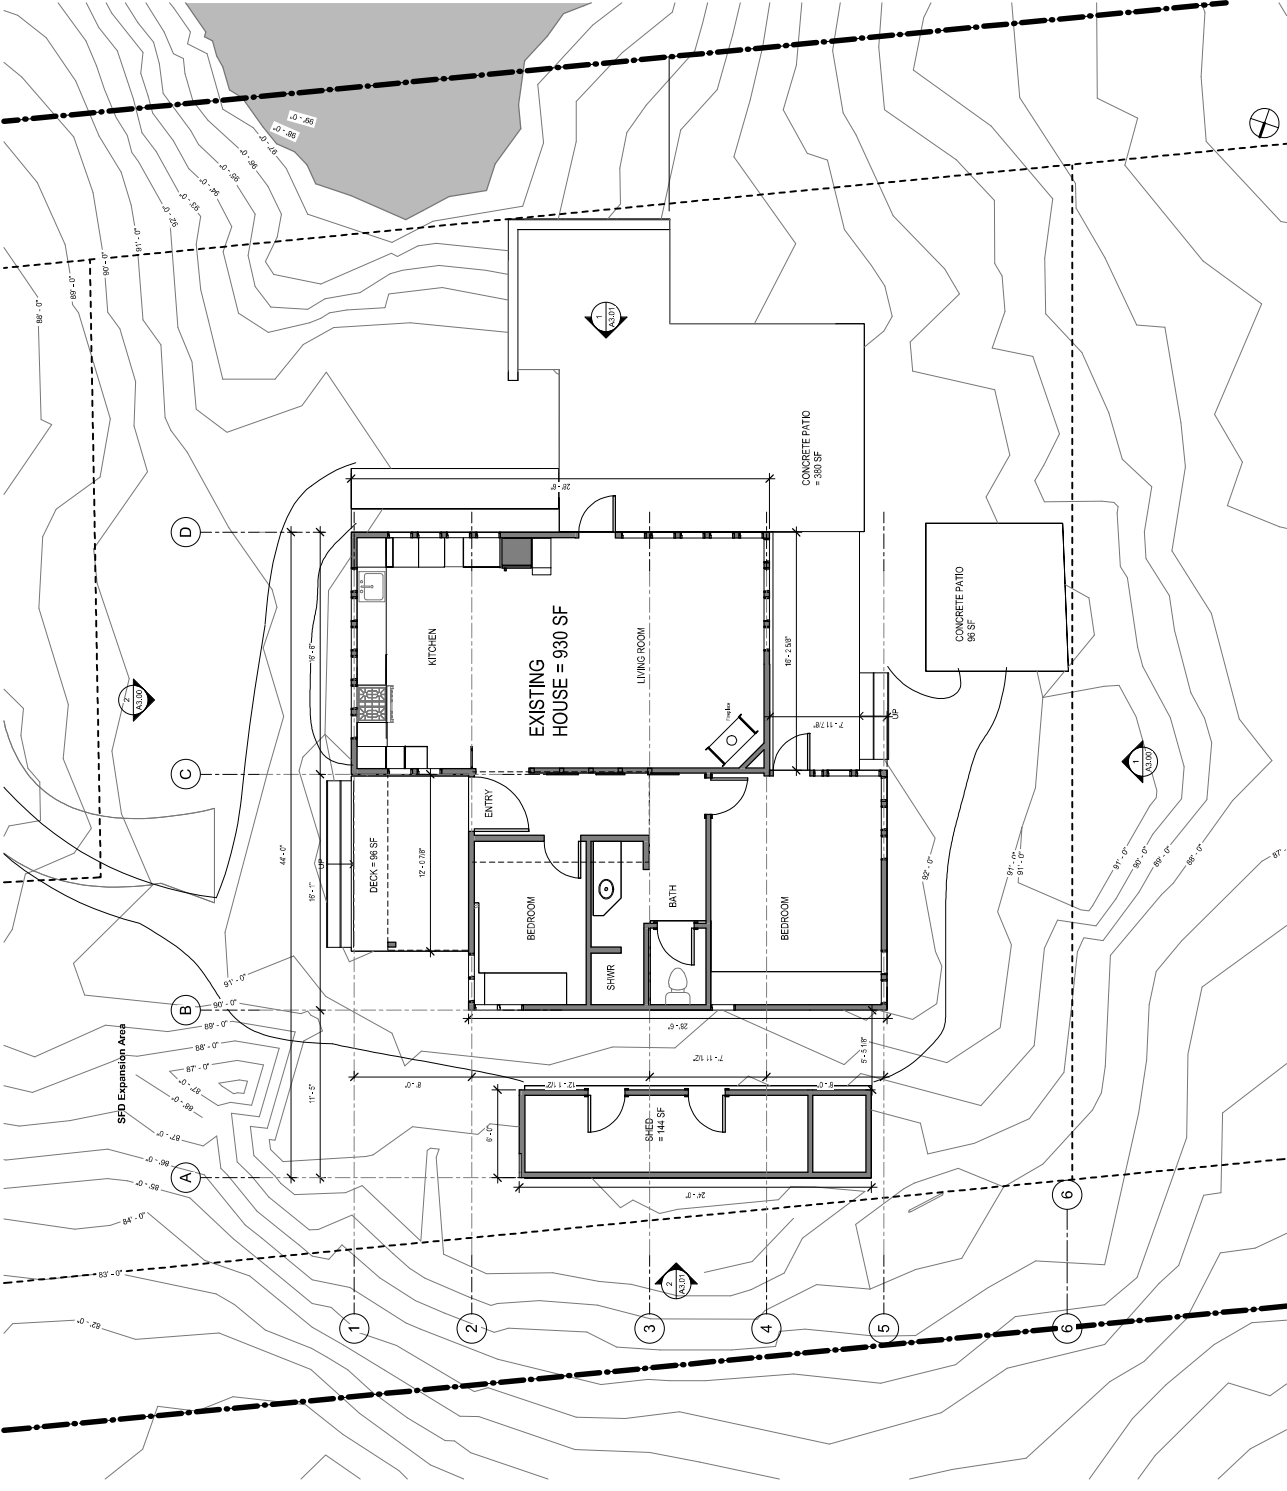
A1.10

1. Floor Plan - Existing  
1/4" = 1'-0"

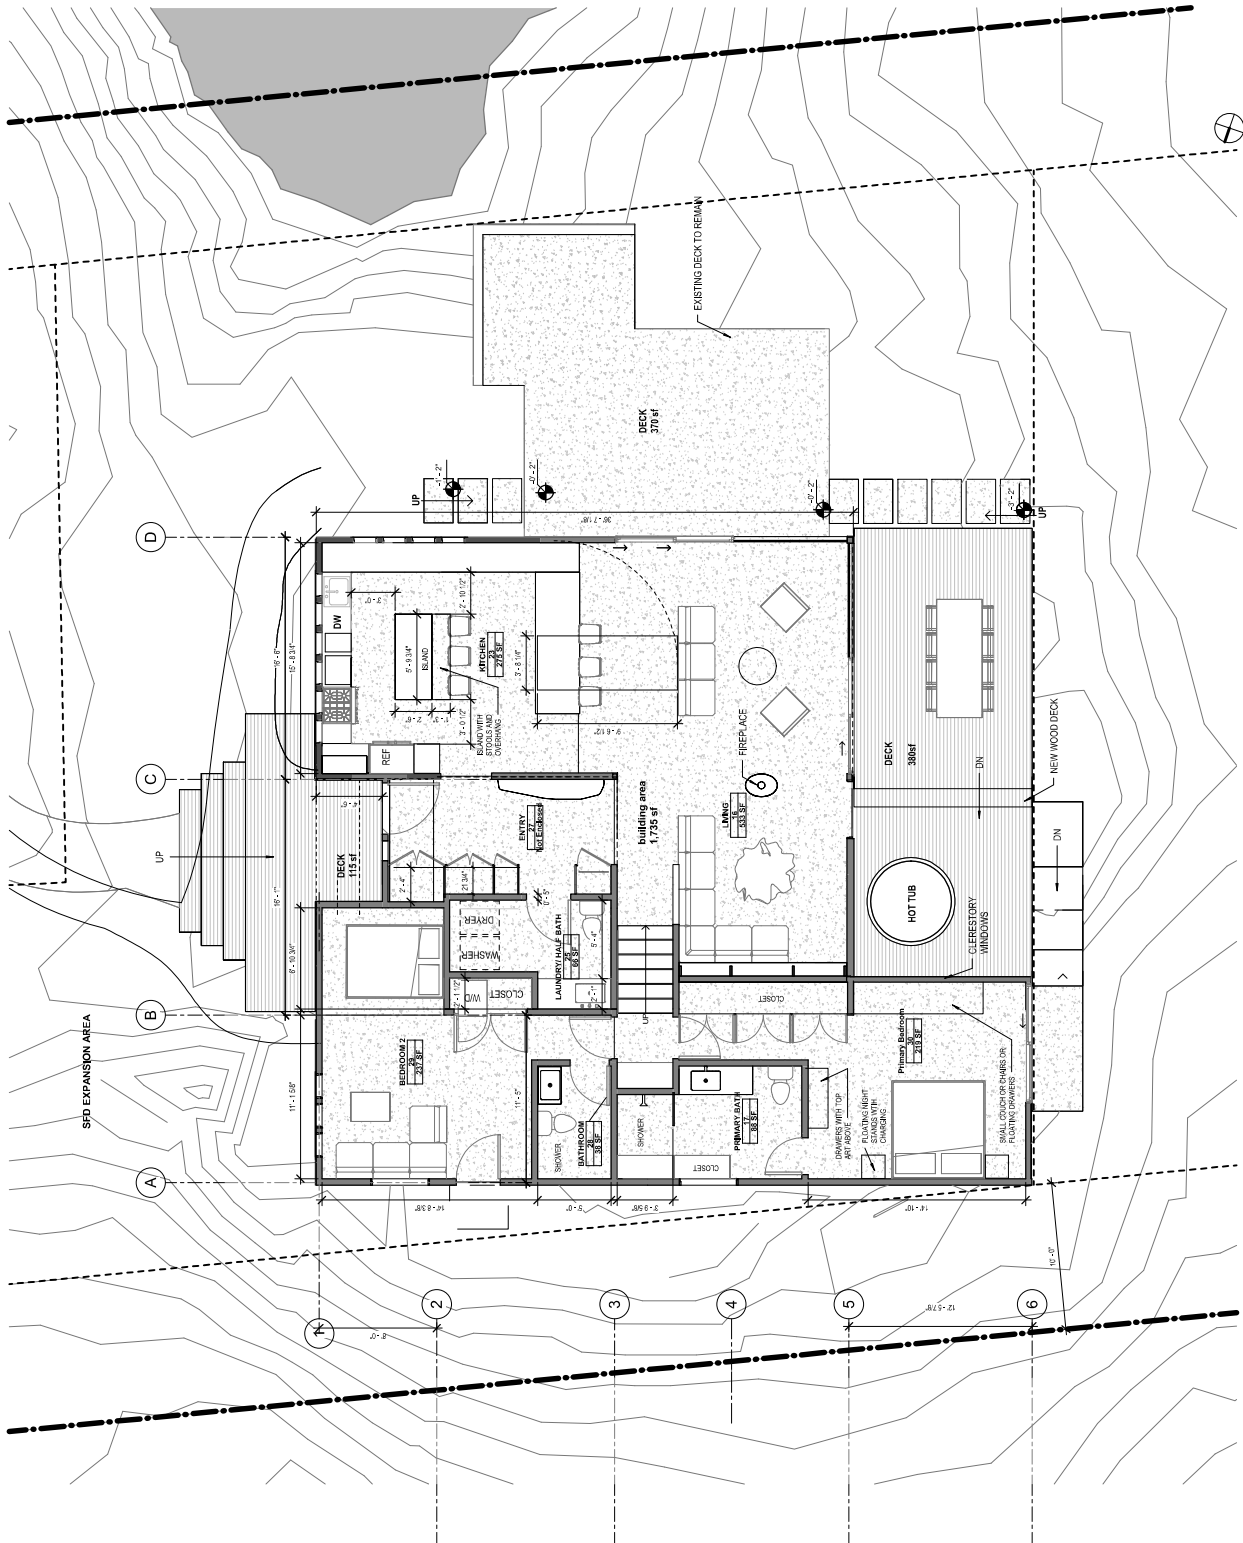
A2.01

PROPOSED FLOOR PLAN  
1/4" = 1'-0"

NEW FOUNDATION, WALLS AND ROOF AT NEW CONNECTED ADDITION.

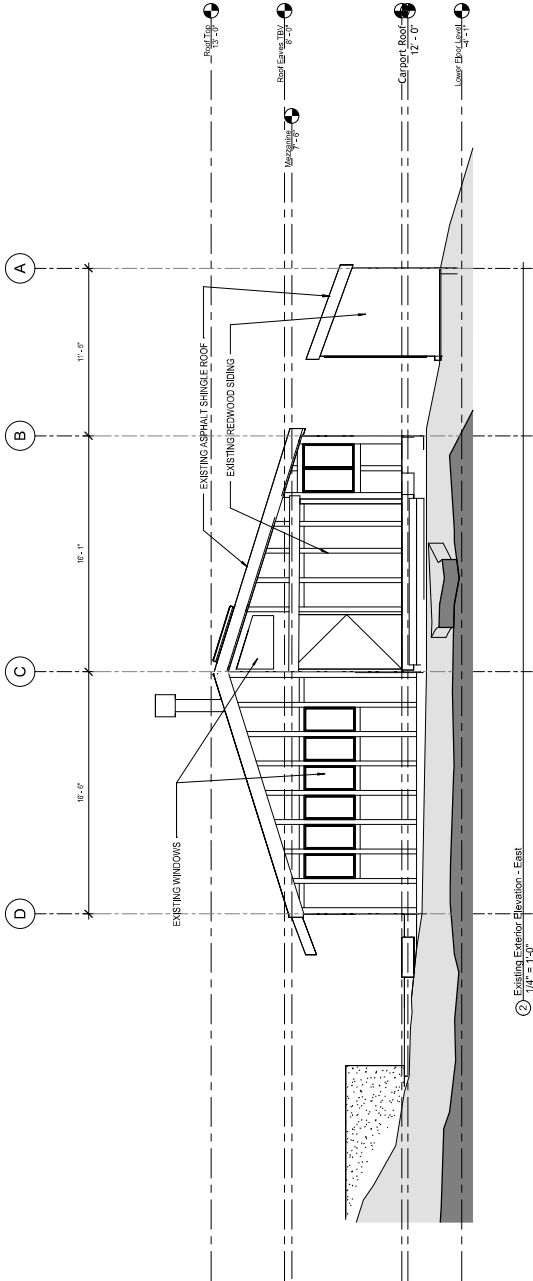
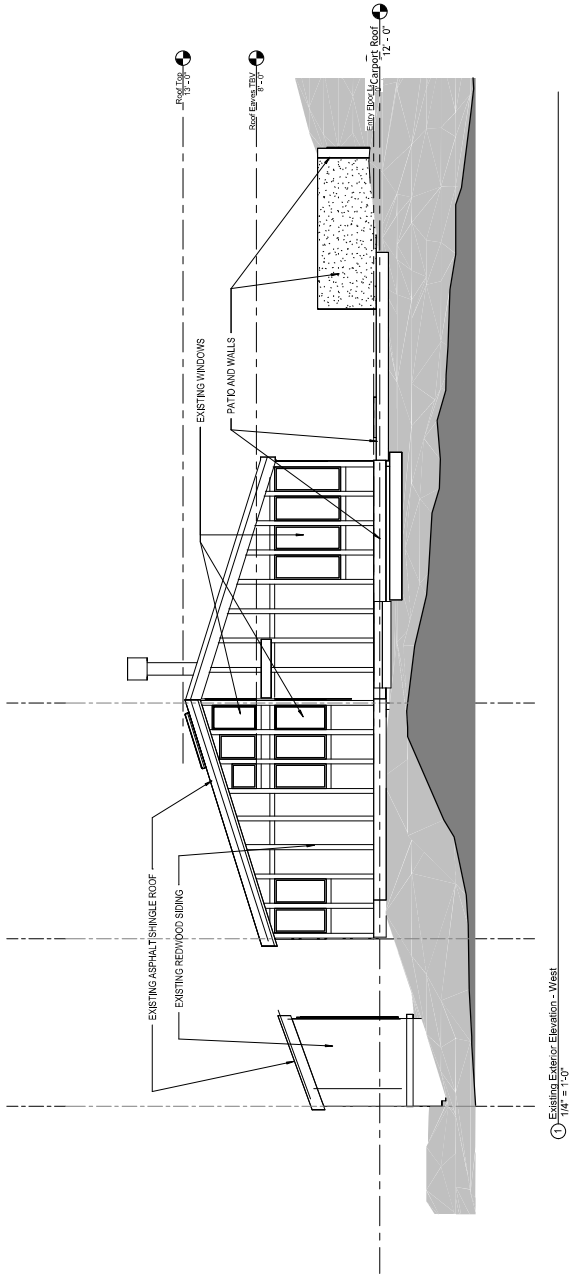
A3.00

Exterior Elevations - Existing

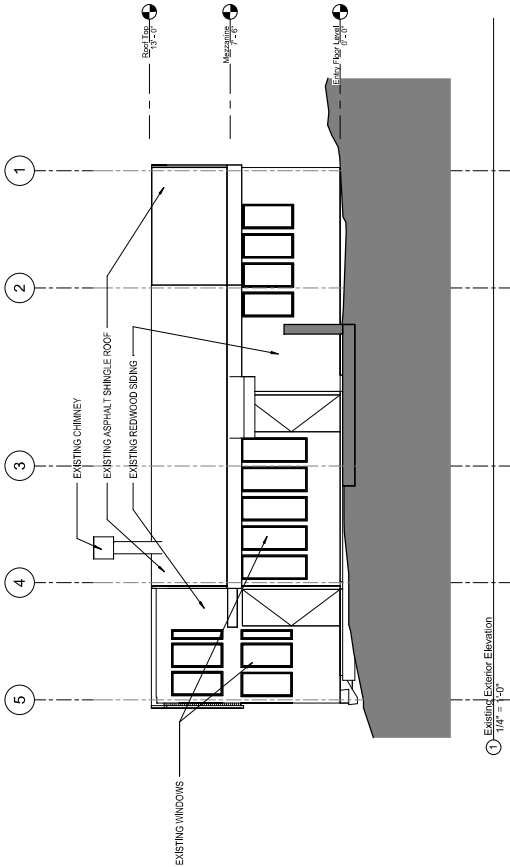
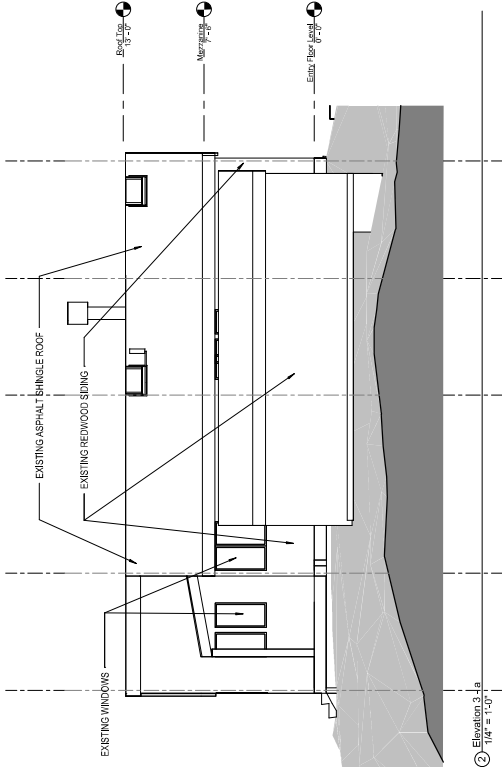
A3.01

Exterior Elevations -  
Existing

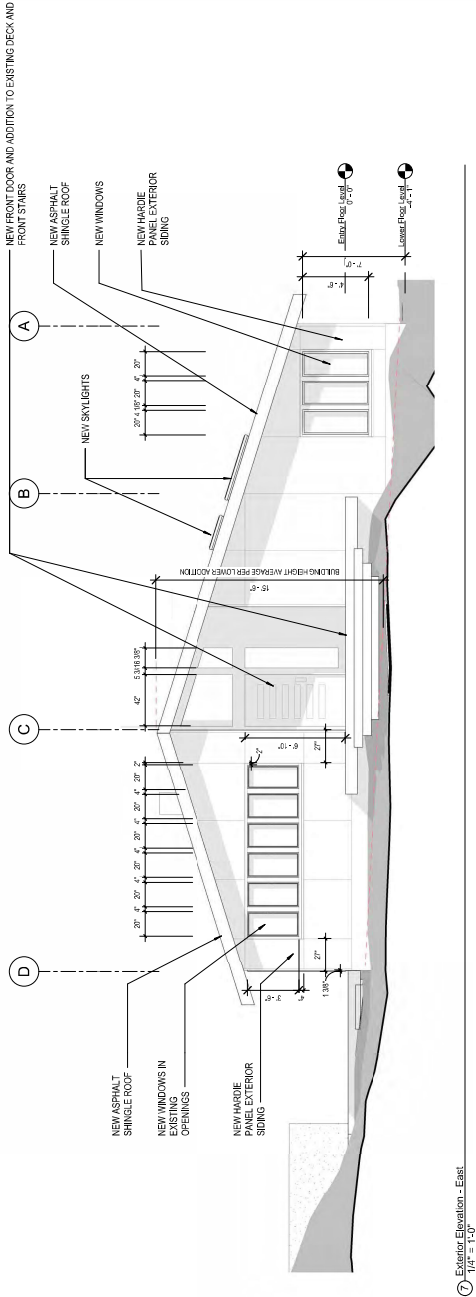
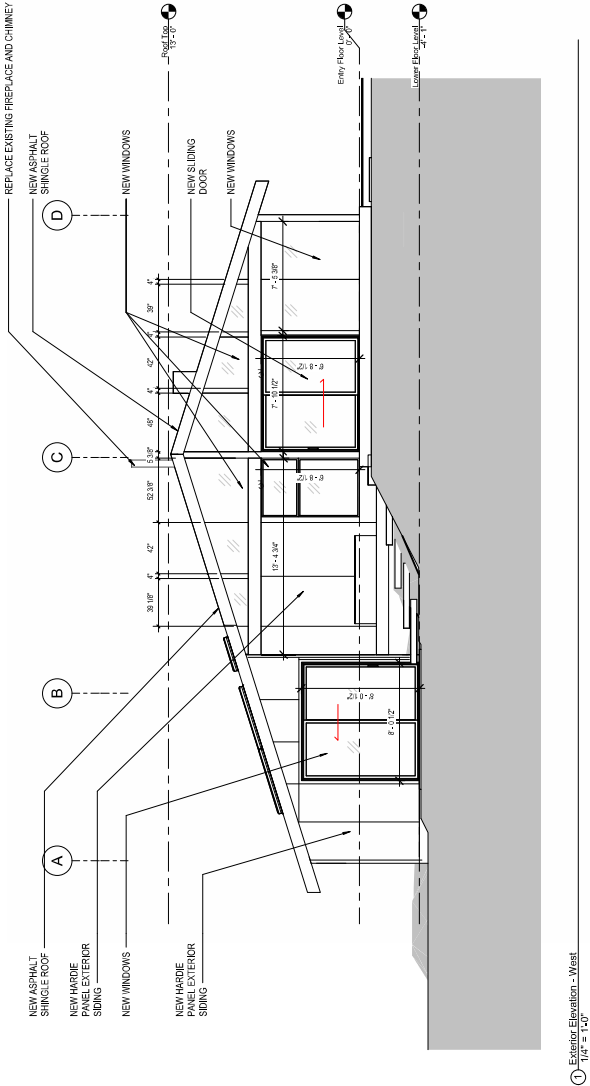
A3.02

Exterior  
Elevations -  
Proposed

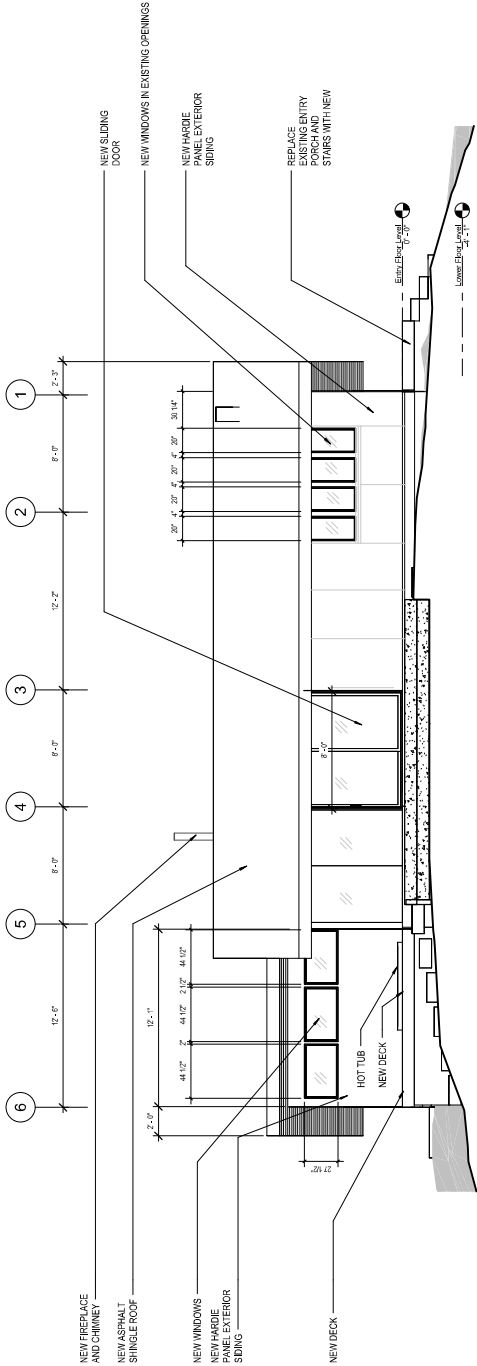
① Exterior Elevation - South  
1/4" = 1'-0"

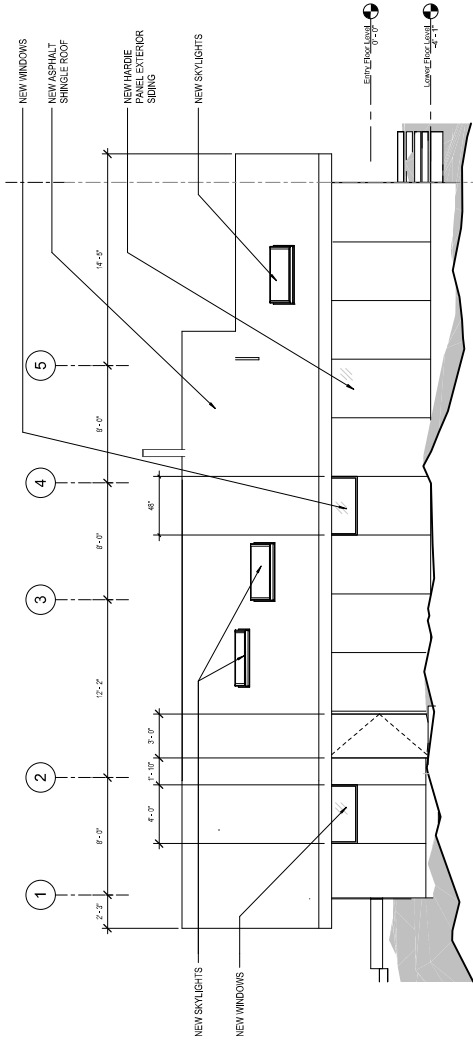
② North Elevation  
1/4" = 1'-0"

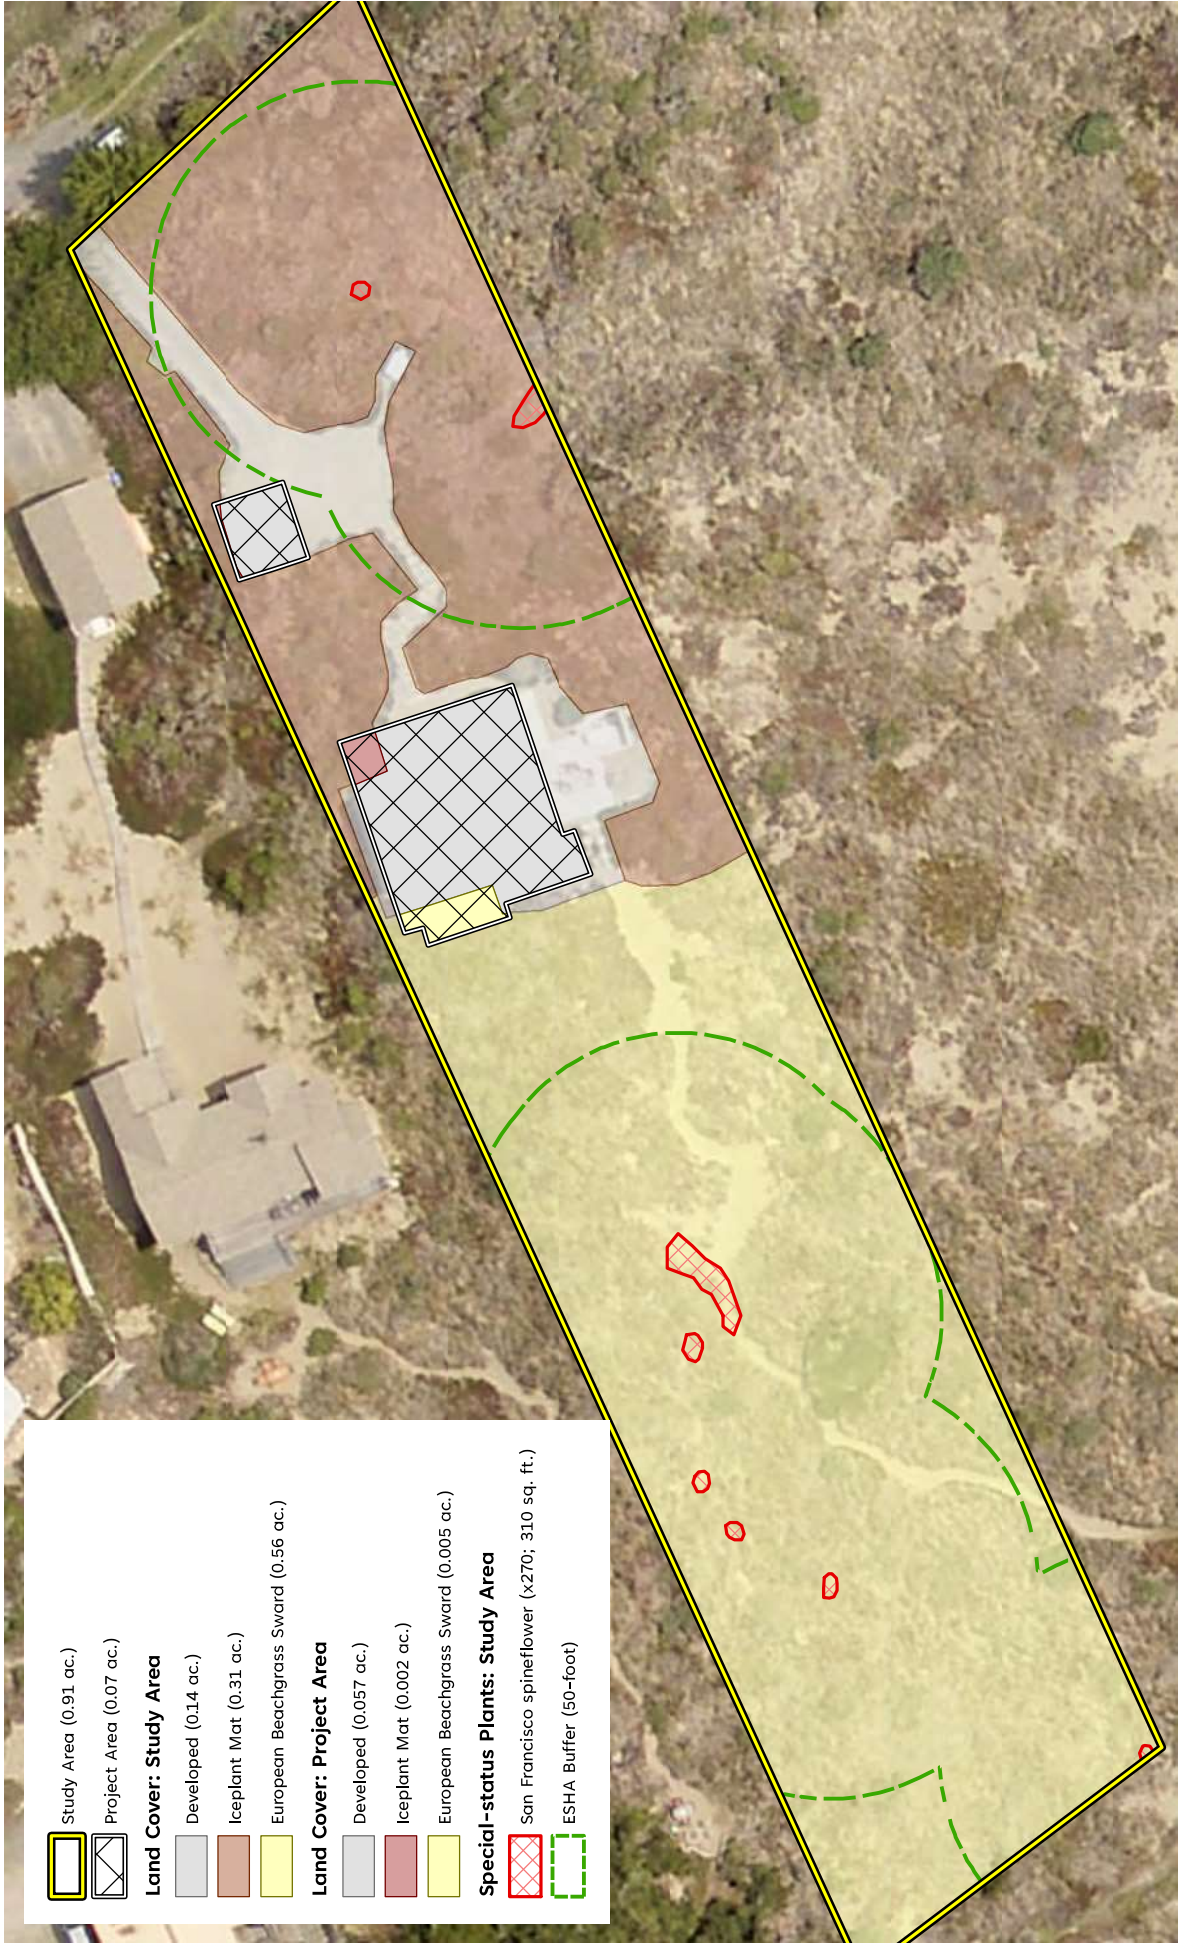
**Figure A-2. Land Cover & Special-status Plants: Study Area & Project Area**

Land cover types observed by WRA within the Study Area include developed, iceplant mat, and European beachgrass sward (Attachment A).

The proposed project has been intentionally and necessarily sited within the developed area to the greatest extent possible. A total of 348 square feet will be sited in iceplant mat and European beachgrass sward land cover types, which are adjacent to the existing development. As noted these areas are severely degraded and support 100 percent absolute cover of non-native invasive species. Therefore, these areas are not sensitive biological resources, should not be considered ESHA, and should require no additional consideration. No further actions are recommended for land cover types.

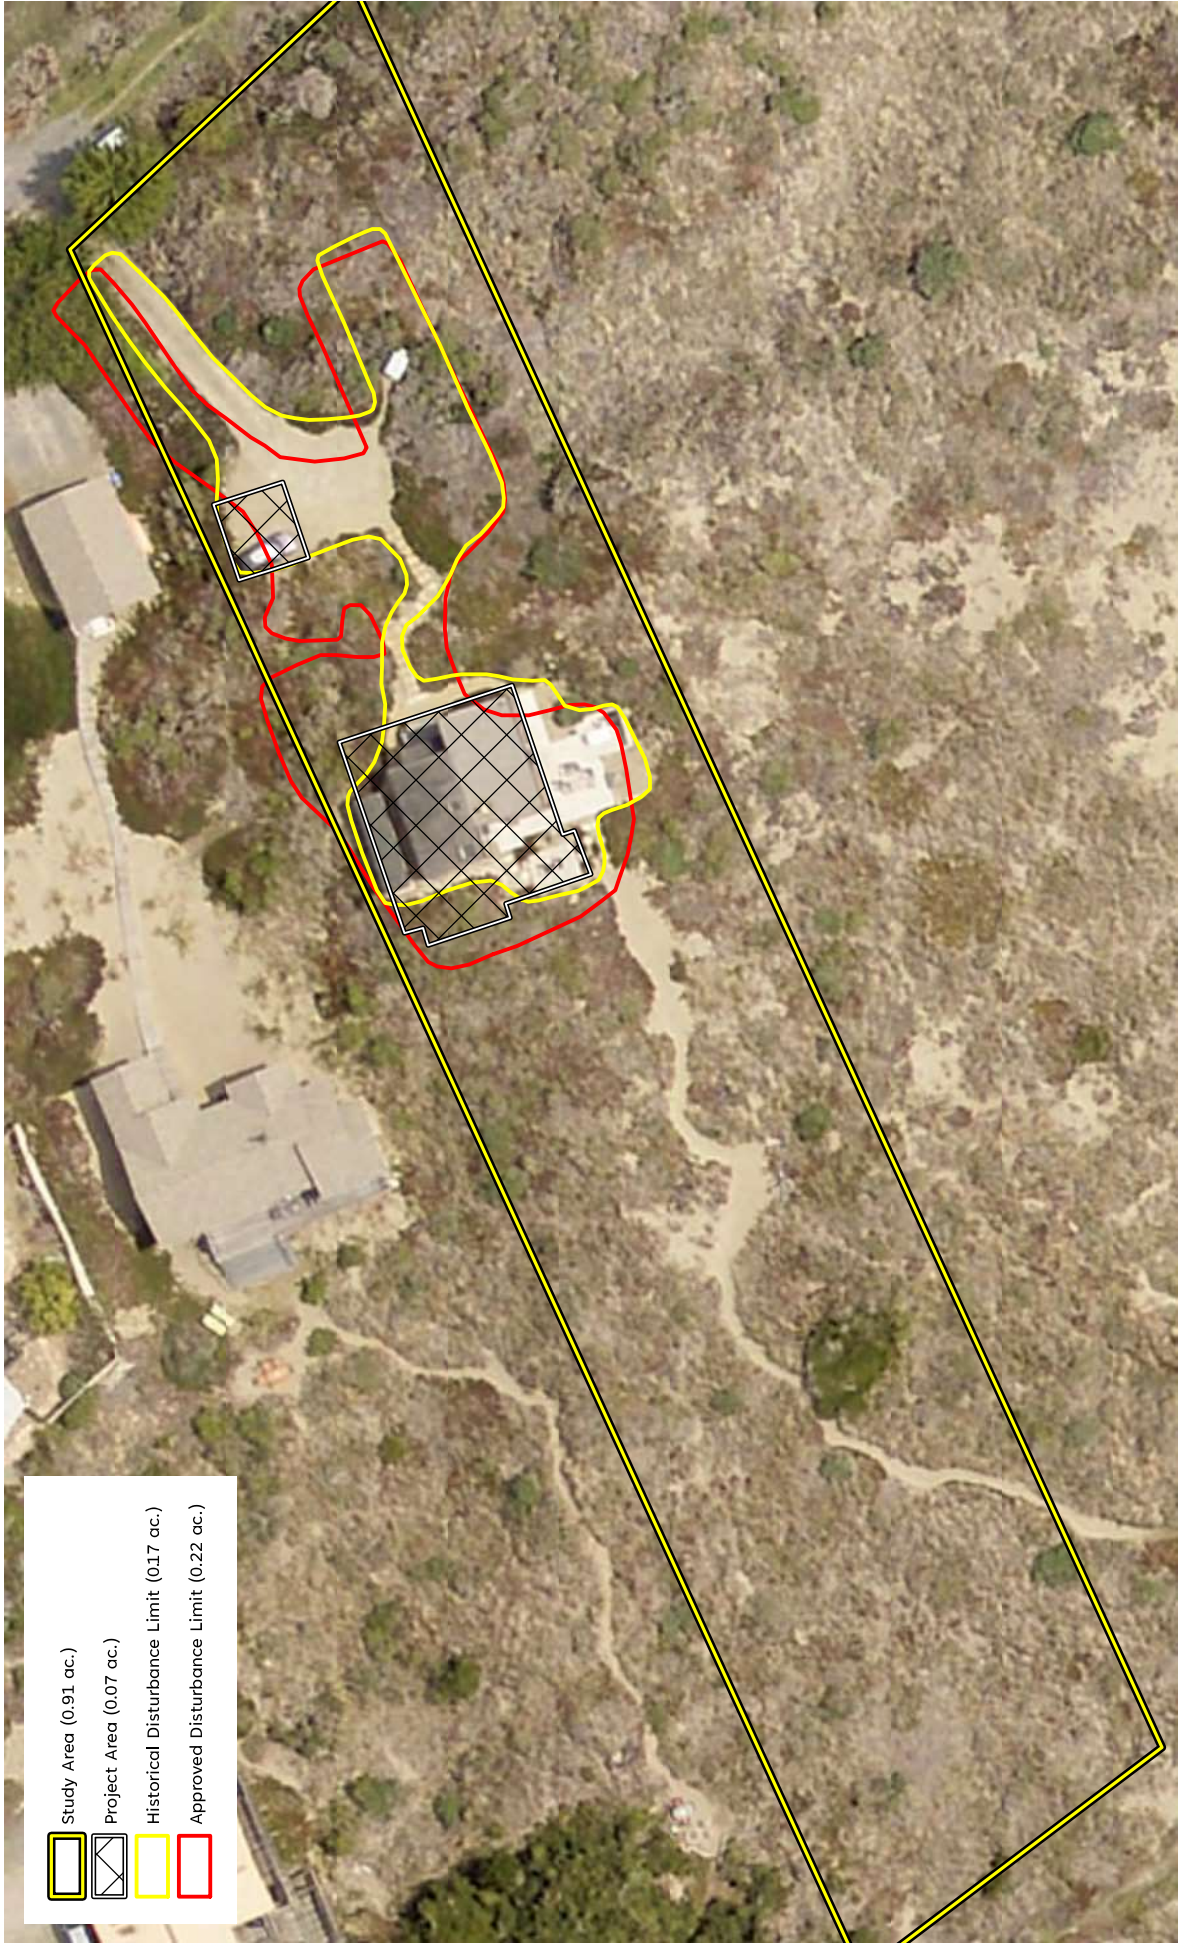
**Figure A-3. Historical Disturbance Limit & Approved Disturbance Limit**

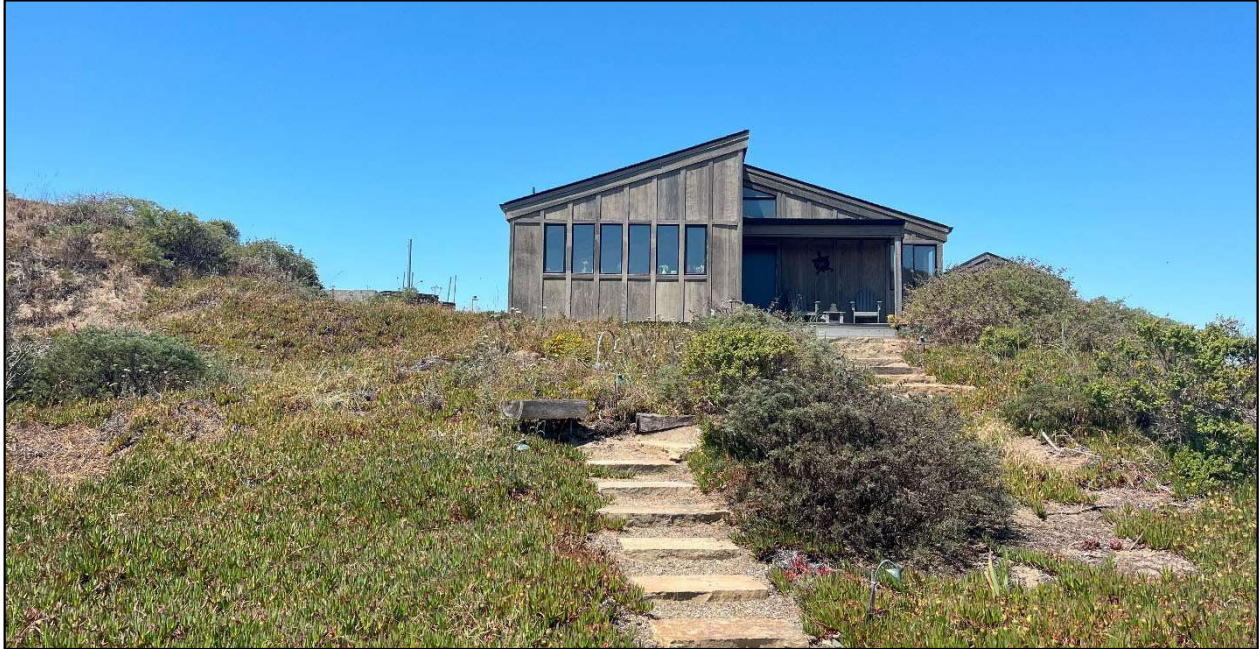
Existing single-family residence, the subject of the proposed project. Note existing development (e.g., stairs, residence) and iceplant mats in the foreground.

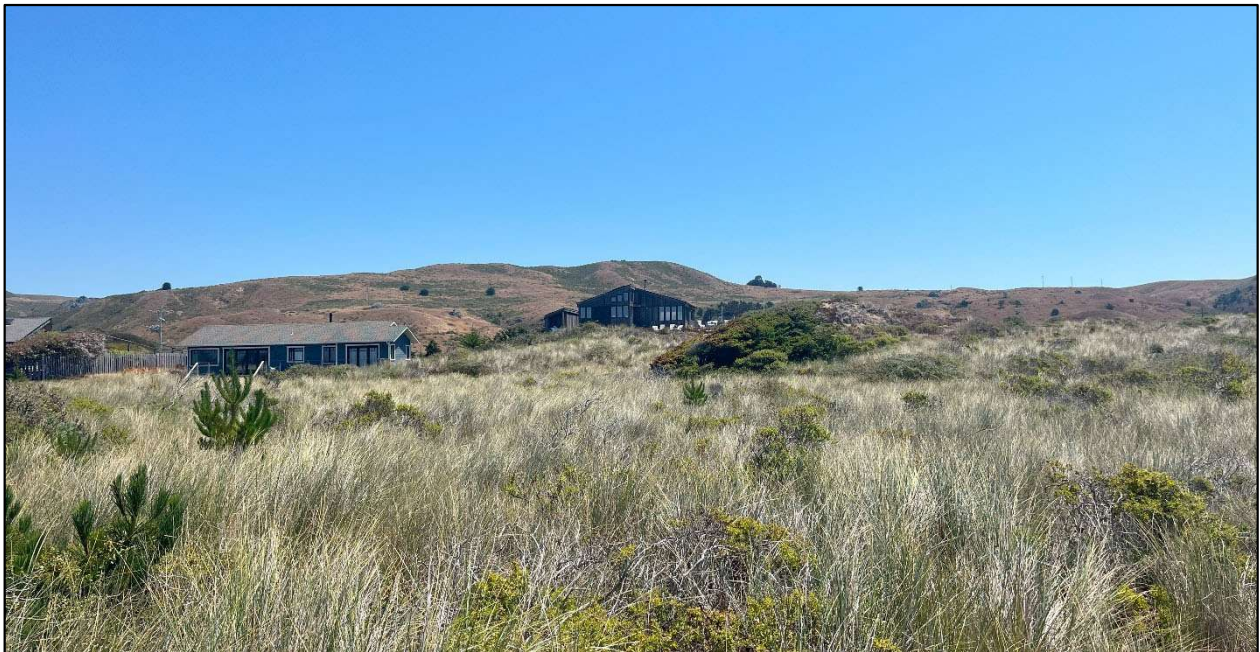
Residence in background from western edge of Study Area with European beachgrass sward in the foreground and middle ground.

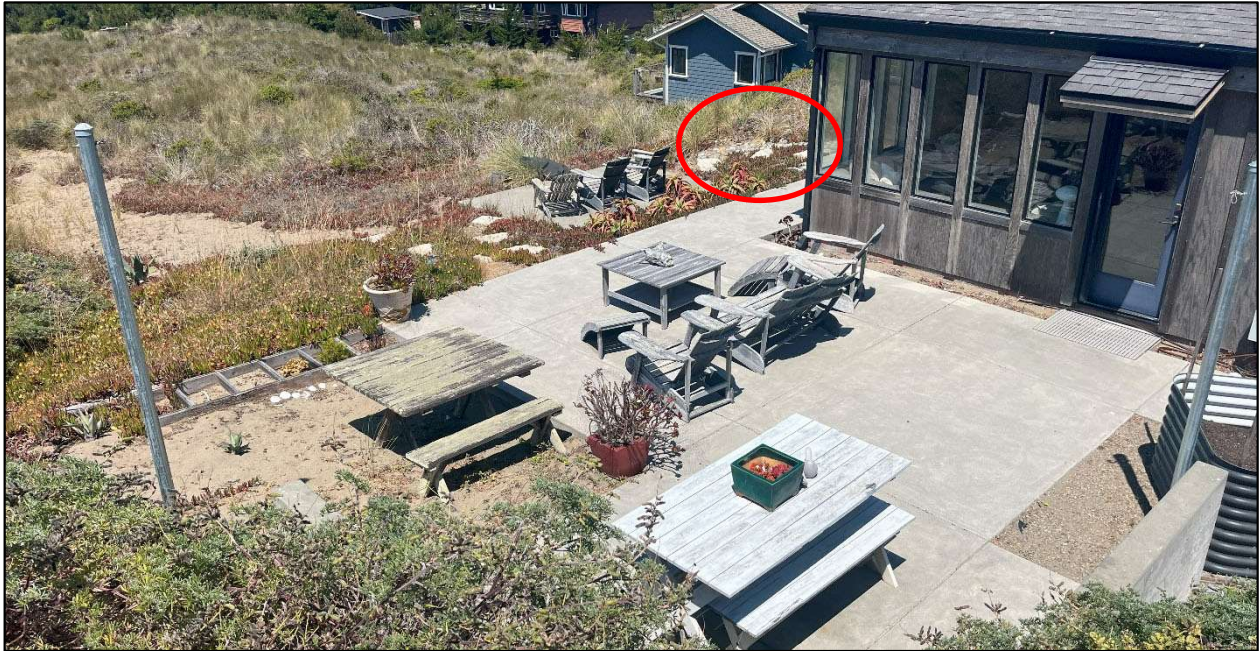
Existing single-family residence, proposed redevelopment in European beachgrass sward circled in red; note the high density of invasive species in this area.

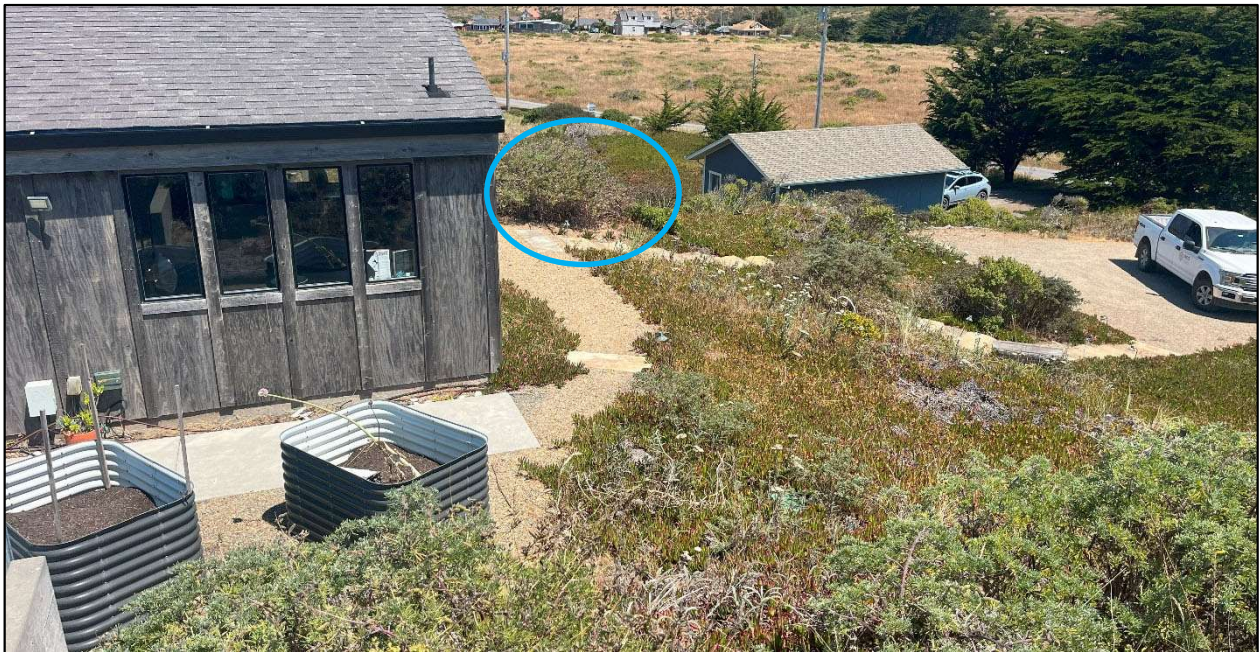
Existing development of residence, proposed redevelopment in iceplant mat circled in blue; note the high density of invasive plants in this area.

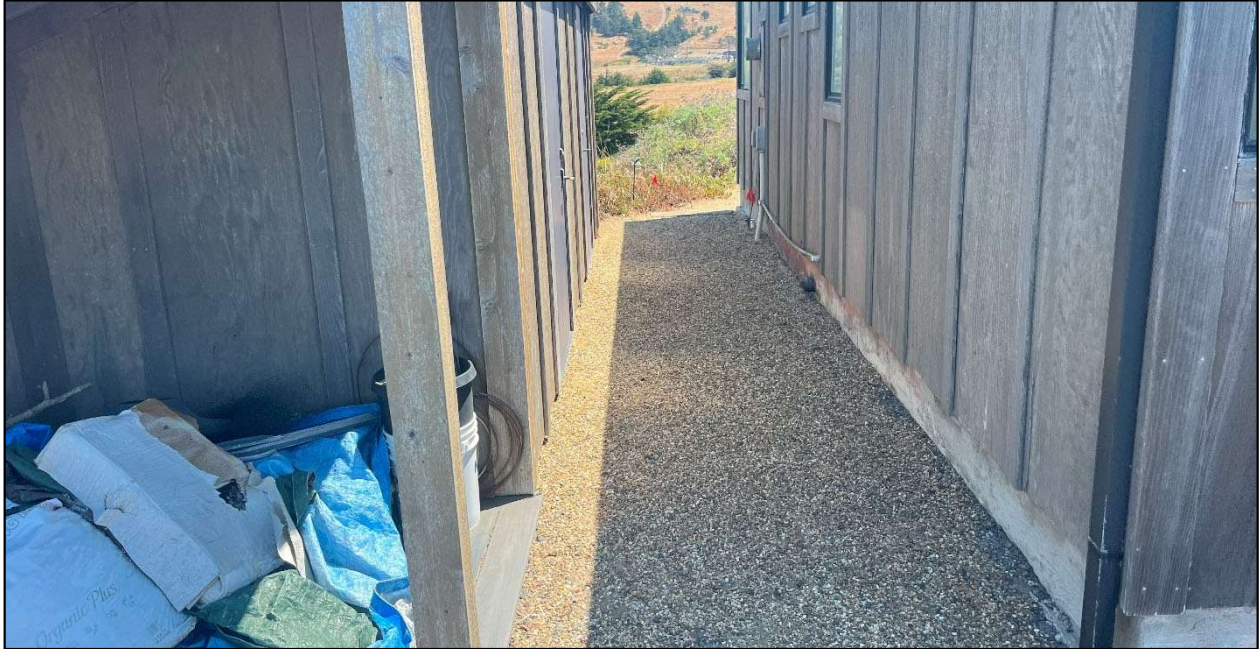
Existing residence and outbuilding to be redeveloped.

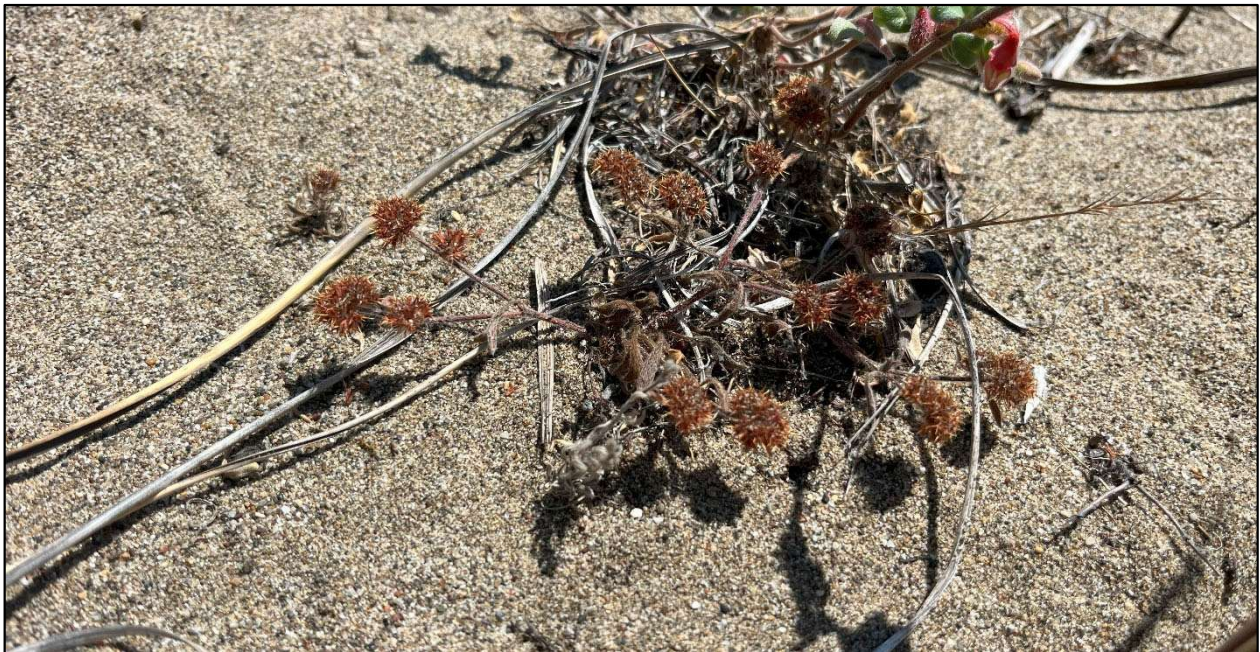
Special-status plant, San Francisco spineflower (*Chorizanthe cuspidata* var. *cuspidata*) individual in small opening in European beachgrass sward on loose sand.

The Study Area contains eight subpopulations of San Francisco spineflower. They are universally situated in openings underlain by loose sands. Because this species has a CNPS Rank of 1B, it is explicitly considered an ESHA according to the LCP. This species is a diminutive annual that requires a certain degree of disturbance (i.e., shifting, loose sands). The proposed project is not located near these subpopulations and a 50-foot buffer with the following restrictions will be sufficient to provide protection.

Recommendation 1: Use the existing parking area and other existing developed areas for laydown of materials and equipment. Inform construction personnel of the presence of these subpopulations and require that they work within the developed areas to the greatest extent feasible.
