The following application has been filed with the Sonoma County Permit and Resource Management Department.

| <b>File Number:</b> | <b>CPH26-0009</b> |
| <b>Site Address:</b> | <b>435 McChristian Ave., Bodega Bay</b> |

**Project Description: Coastal Permit with Hearing to expand the original 930 sq. ft. house to a 1,752 sq. ft. primary residence with a new 144 sq. ft. shed and 36 sq. ft. carport on a 1.0-acre parcel. The proposed building height will remain unchanged and additional massing is minimal. The carport will match the house design and be located within the existing parking area.**

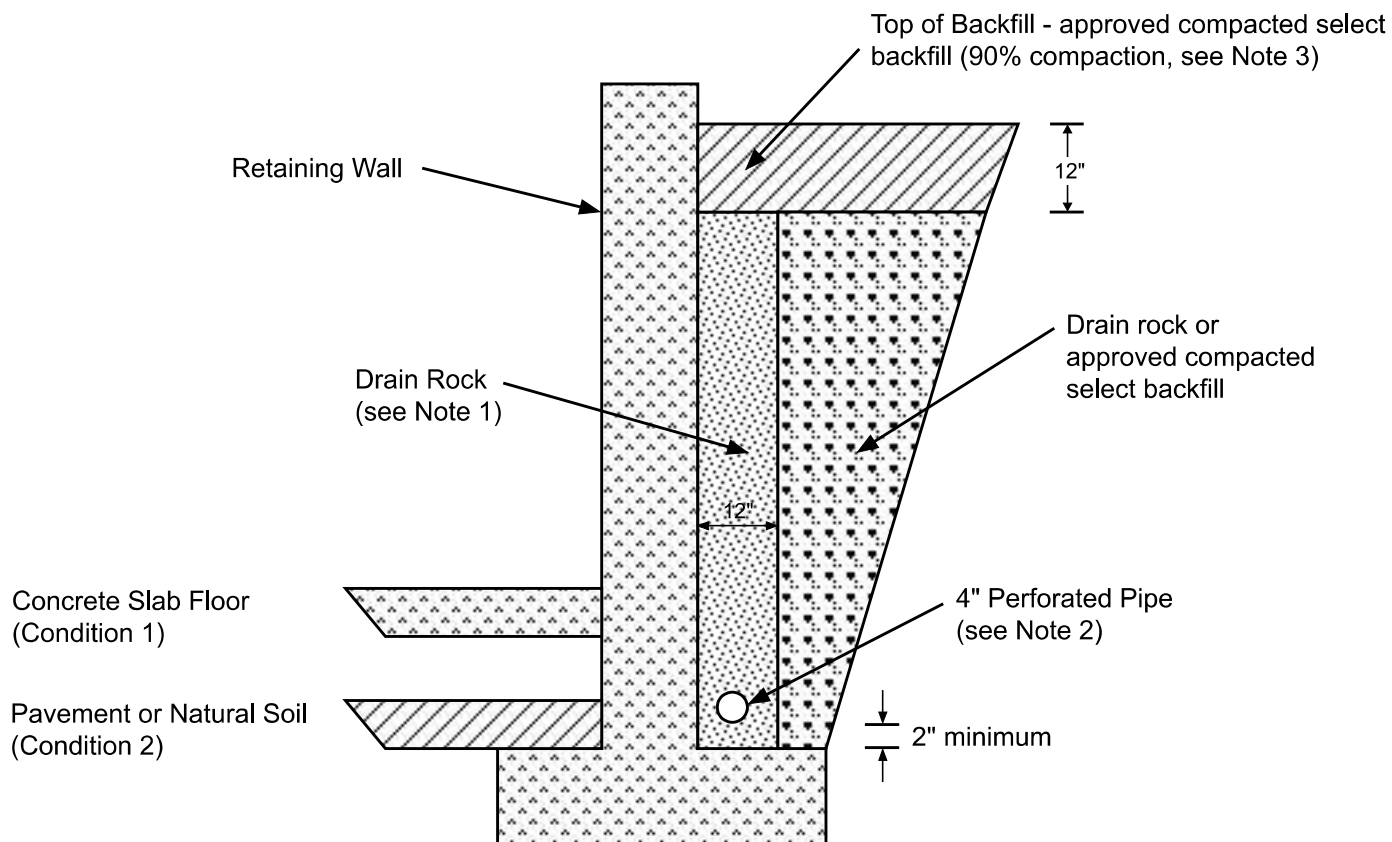
**WALL DRAINAGE DETAIL**  
(Not to scale)

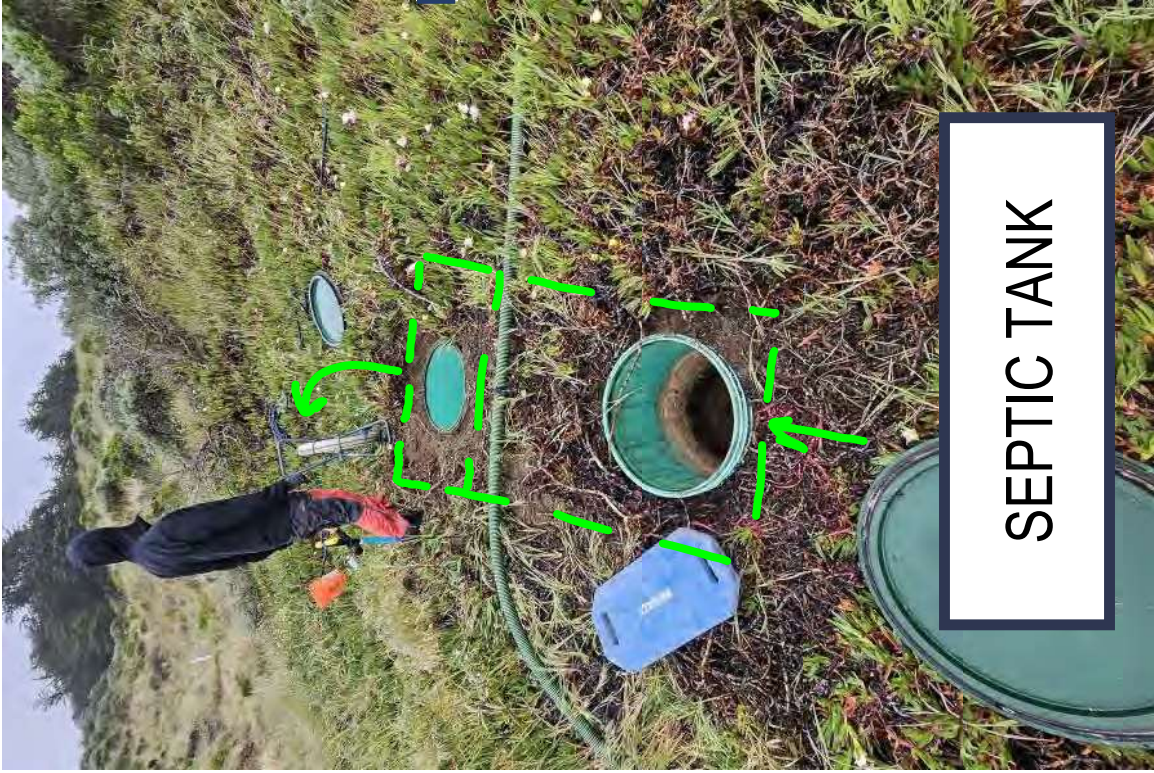
SEPTIC TANK

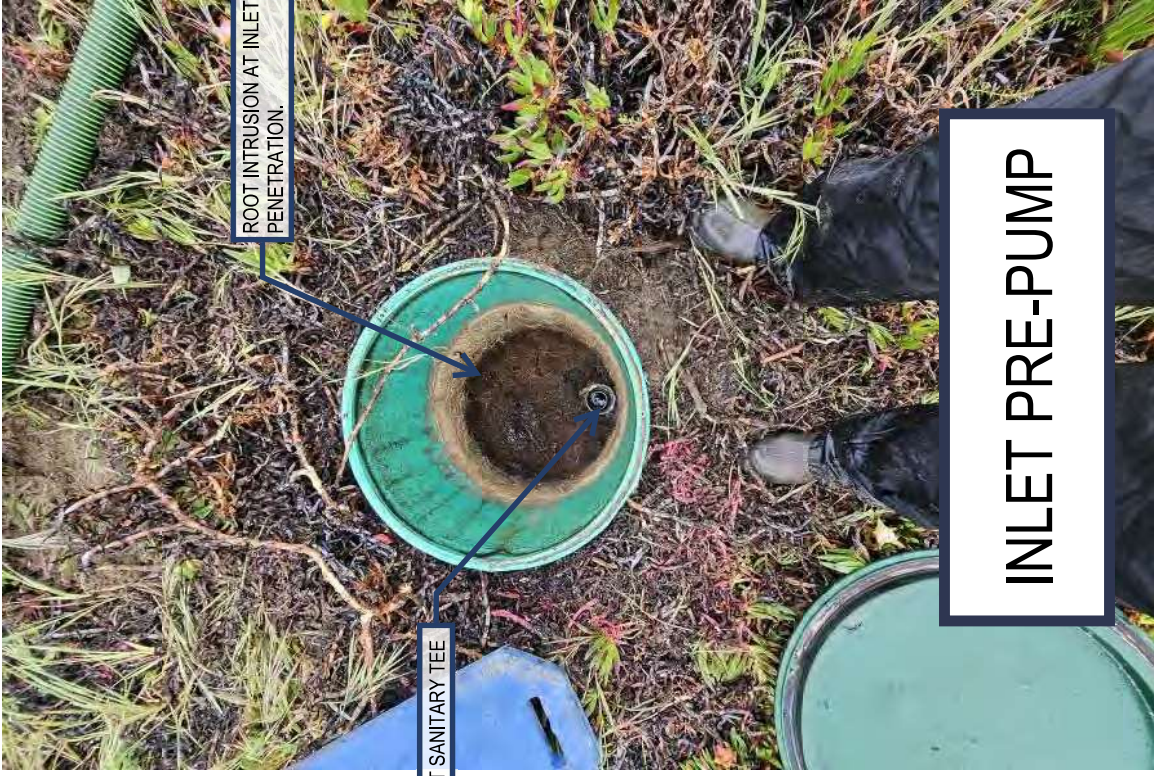
ROOT INTRUSION AT INLET TEE  
PENETRATION.

(E) INTLET SANITARY TEE

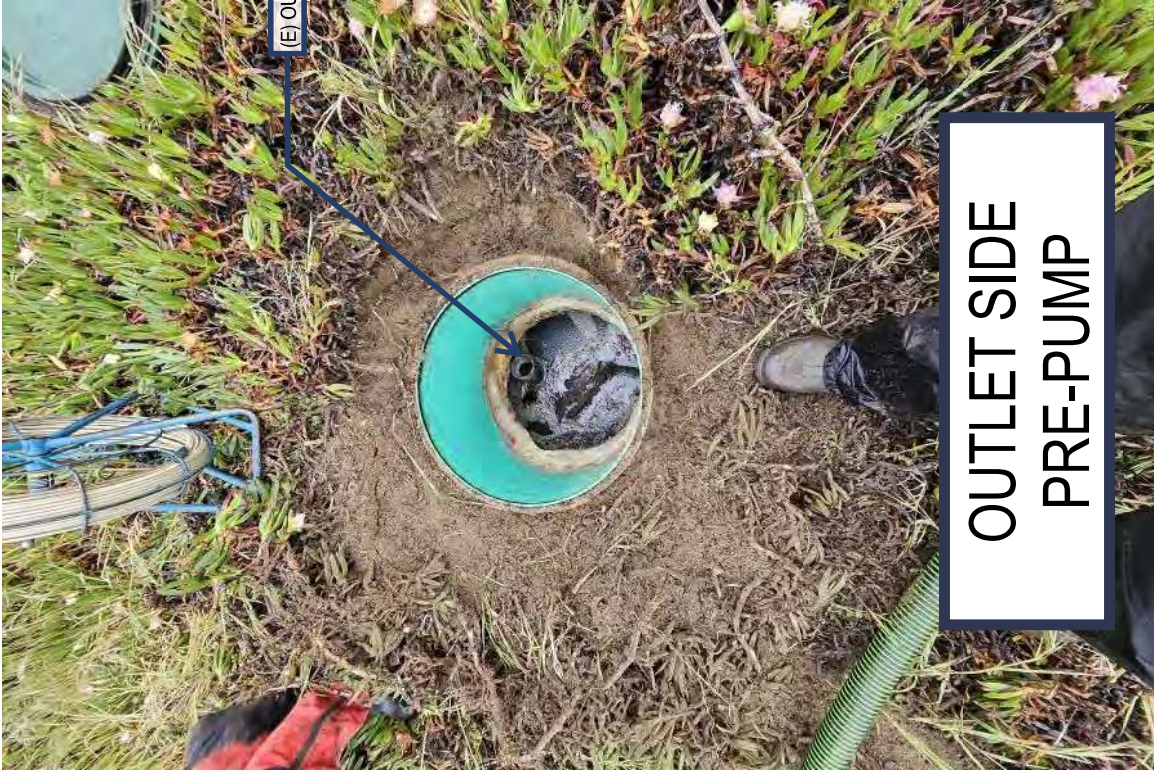
OUTLET SIDE  
PRE-PUMP

(E) OUTLET SANITARY TEE

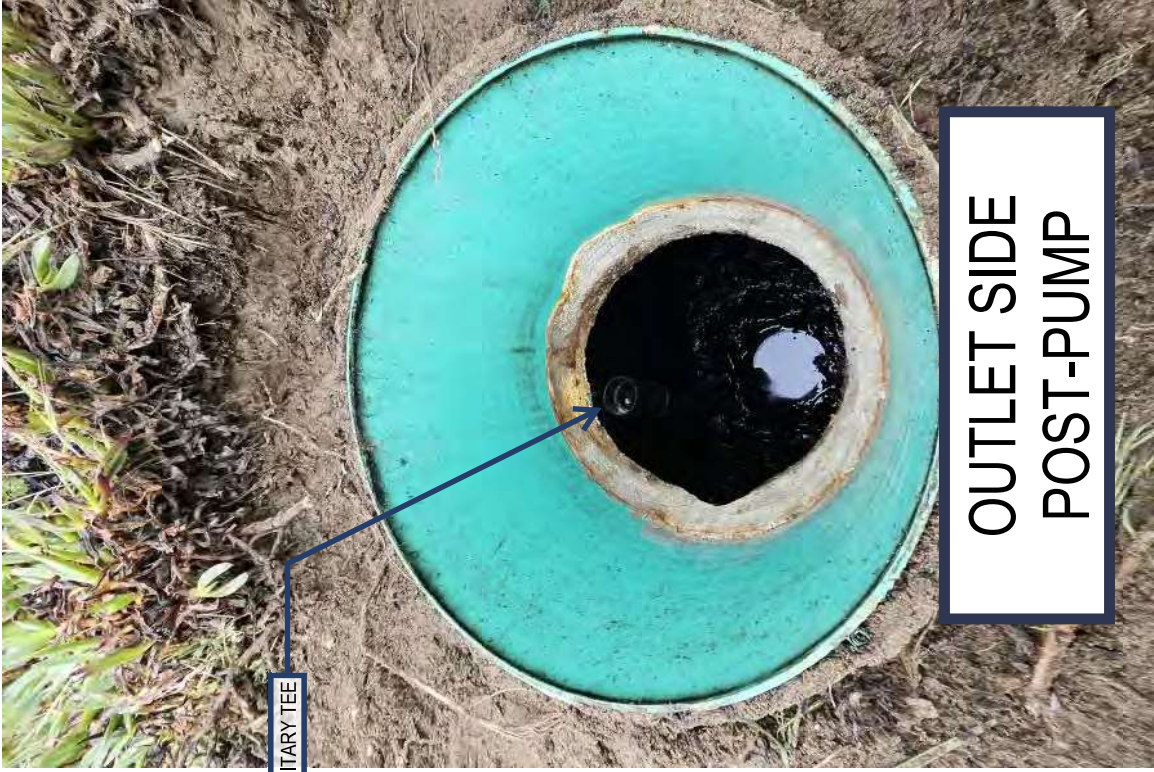
OUTLET SIDE  
POST-PUMP
