PJC & Associates, Inc.
Consulting Engineers & Geologists

Subject: Soil and Foundation Investigation
Proposed Historic Barn Retrofit
Sea Ranch Lodge
60 Sea Walk Drive
Sea Ranch, California

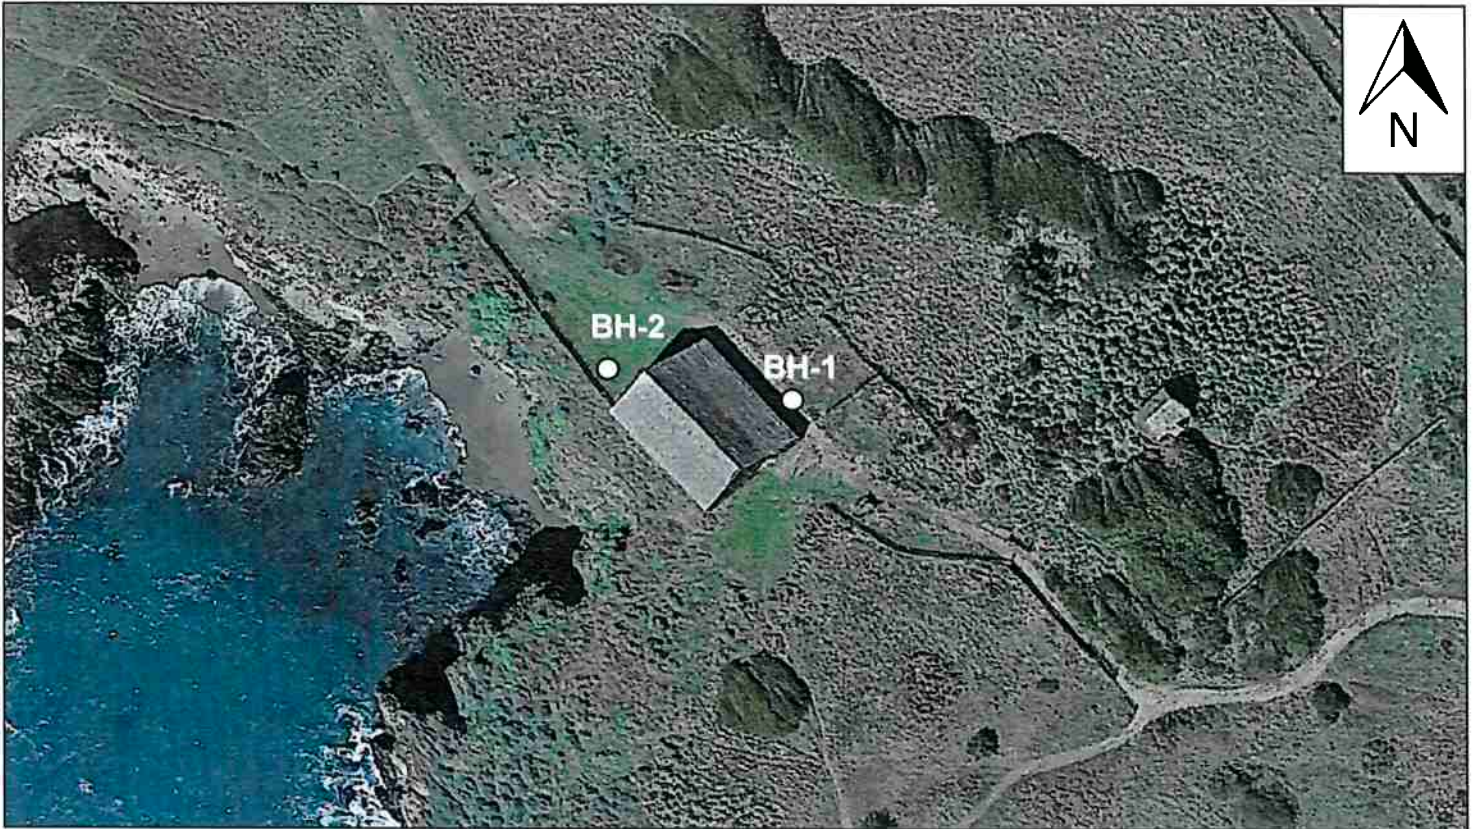
APPROXIMATE SCALE: 1"=80'

EXPLANATION

- a. Soils. The subsurface conditions at the project site were investigated by drilling two shallow exploratory boreholes (BH-1 and BH-2) at the site to a depth three and one-half feet below the existing ground surface. The boreholes were advanced to observe the subsurface conditions and to collect soil samples of the underlying strata for visual examination and laboratory testing. The drilling procedures are included in Appendix A of this report. The laboratory procedures are included in Appendix B. The descriptive boreholes are included in Plates 3 and 4.
