Wetland & Riparian Habitat

Restoration, Mitigation, and Monitoring Plan

Canyon Rock Quarry, Sonoma County

Prepared for: Carlile-Macy & Benchmark Resources Prepared by: Charles A. Patterson, Plant Ecologist February 28, 2025

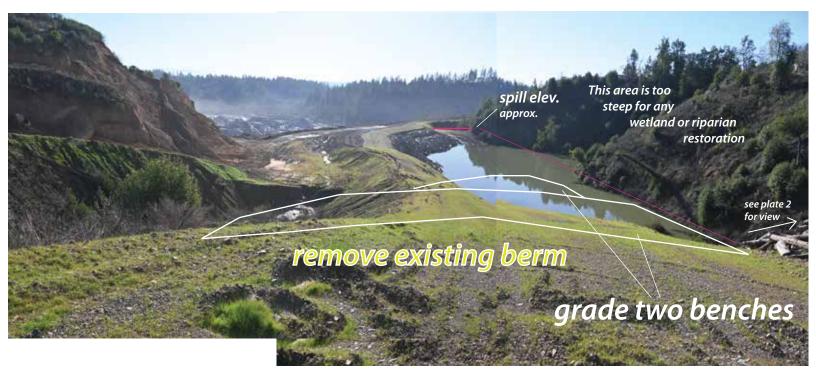
Plate 1. Looking south across reclamation area, showing existing pond and berm. After removal of the berm and reconnection of the small watershed area (to the left), two level benches would be graded roughly as shown above, at approximately three and five feet below the pond's spill elevation. Canyon Rock Quarry, Forestville; February, 2025.

Option 6 would be to backfill the uppermost portion (about 0.6 total) of the pond footprint, creating two level benches (see Figure 3) that stair-step slightly downward into the pond basin, and which capture the incoming runoff from the main drainage, plus the smaller one that will be reconnected to the pond (by removing the tall berm). These benches would be graded relatively flat, with a low (one foot) lip or berm to retain ponding on each bench, and would receive a thin (3 to 8 inches) layer of local clay compacted into each bench to help seal the soil. These benches would be placed at three and five feet below the ultimate pond spill elevation, and would be planted with a variety of native wetland and riparian plants. Since they would be placed where incoming runoff naturally flow, the two constructed benches would be essentially guaranteed at least a relatively reliable water source. With clay lining and low containment berms, the bench areas would almost certainly become and stay ponded each winter, and with average rainfall, the overall pond filling to capacity would ensure full inundation. Natural ponding that currently occurs until sometime in May or June in the main pond should help facilitate the benches getting a good winter and spring soaking. The benches should then remain wet or damp well into, if not through summer, with most species to be planted being tolerant of at least some drying in the late summer and fall.

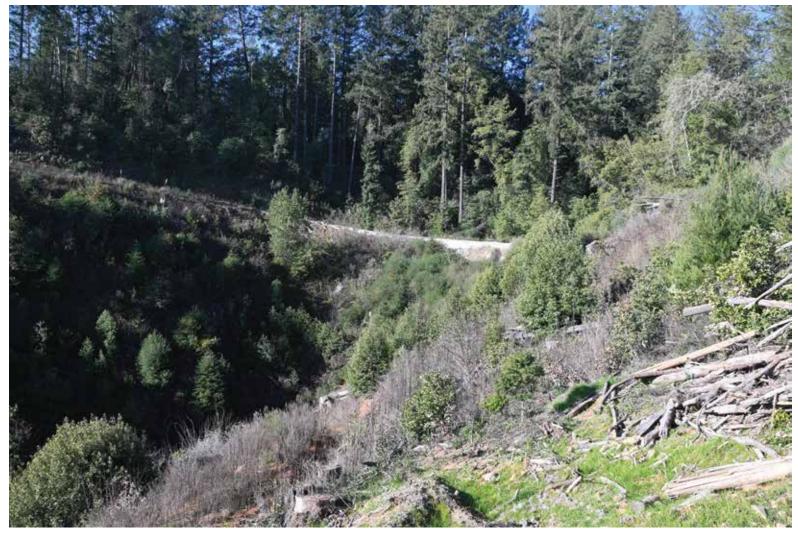
Plate 2. Looking NNW up the small drainage/watershed area that feeds the existing pond from the northwest (a portion of the area discussed under 'Option 3').

- 3) Construct/create similar (wetland and riparian) conditions along the undisturbed uppermost section of this drainage (above the quarrying in the extreme northwest corner).

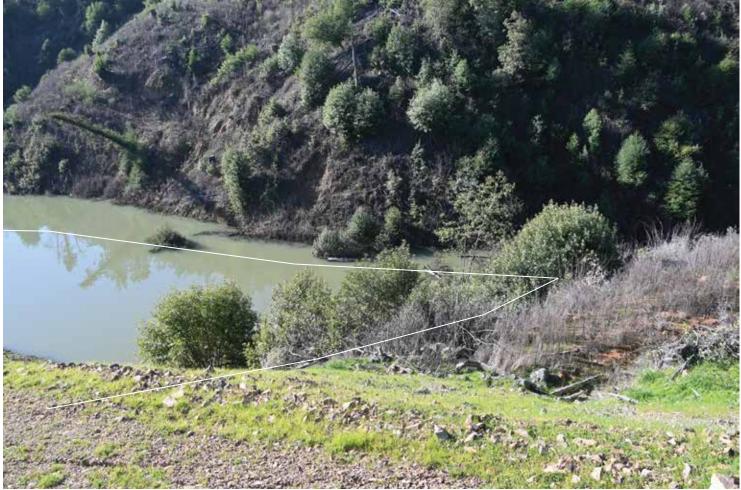
Plate 3. Northwestern arm/inlet for the existing pond; white line shows rough placement of bench to be graded.

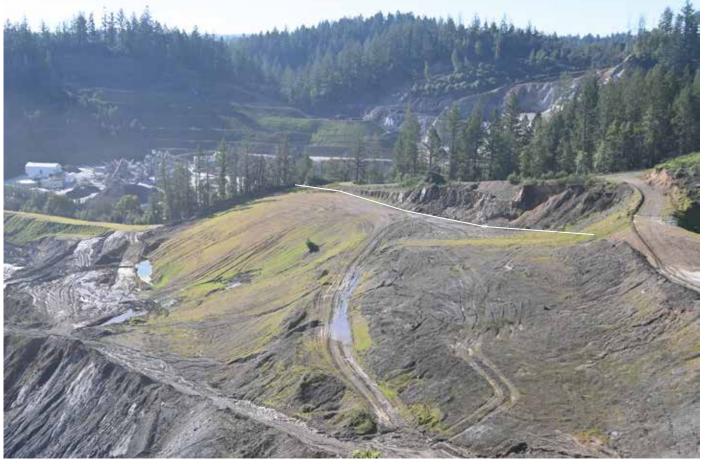
Plate 4. Looking SW at area below pond; white line approximates the route for re-channeling the overflow from the pond back toward Highway 116. This area is not especially suitable for attempting wetland or riparian restoration ('Option 2').

- 1) Construct a similar ephemeral drainage in a new location nearby, roughly replicating the original drainage's attributes.
- 2) Construct/create similar (wetland and riparian) conditions along the lower section of the new/replacement drainage feature to be built reconnecting this upper watershed area back to a ditch along Highway 116.
