September 11, 2023

Geotechnical Engineering Report Update  
Shade Structure  
Sonoma Cutrer Vineyards  
4401 Slusser Road  
Windsor, California

Project Number: 1099.18.12.1

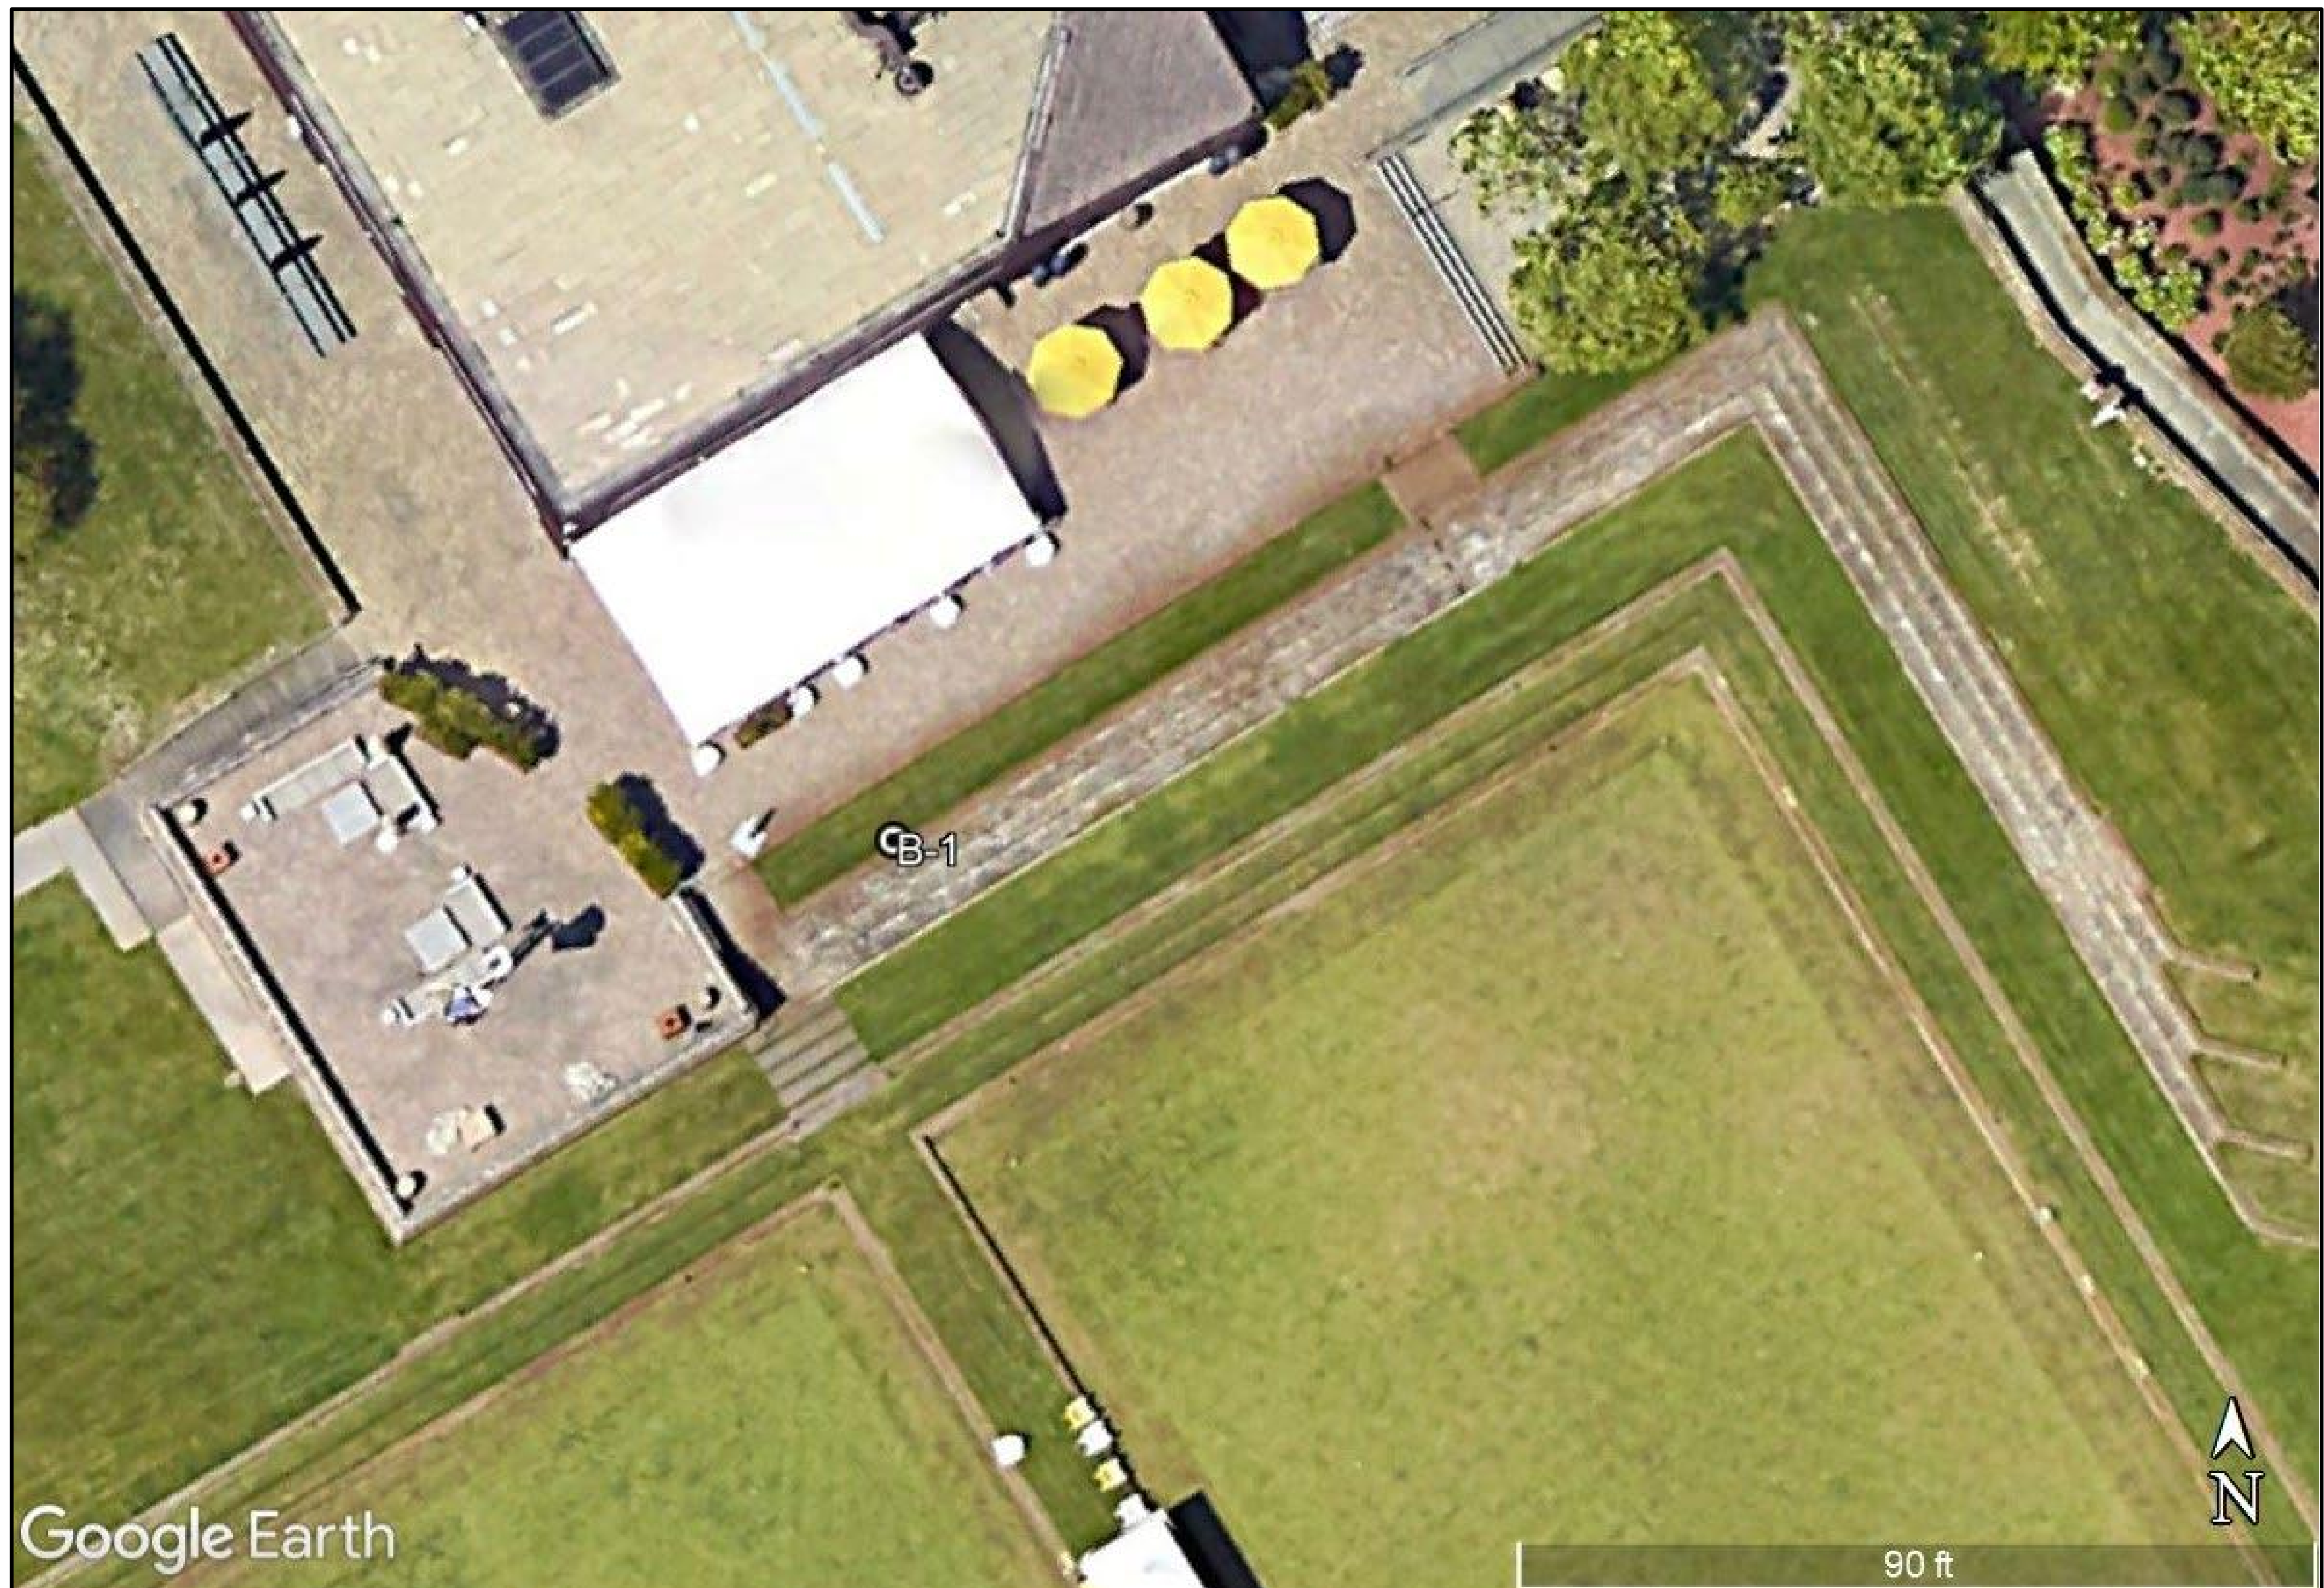
We reviewed our previous geotechnical studies at the facility. On August 9, 2023, we performed a geotechnical reconnaissance of the site and explored the subsurface conditions by drilling one boring to a depth of about 15½ feet. The boring was drilled with a portable drill rig equipped with 4-inch diameter, solid stem augers at the approximate location shown below. The boring location was determined approximately by pacing its distance from features shown below and should be considered accurate only to the degree implied by the method used. Our project engineer located and logged the boring and obtained samples of the materials encountered for visual examination, classification, and laboratory testing.
